# SAFETY DIGEST

Lessons from Marine Accident Reports

2/2023

# MARINE ACCIDENT INVESTIGATION BRANCH

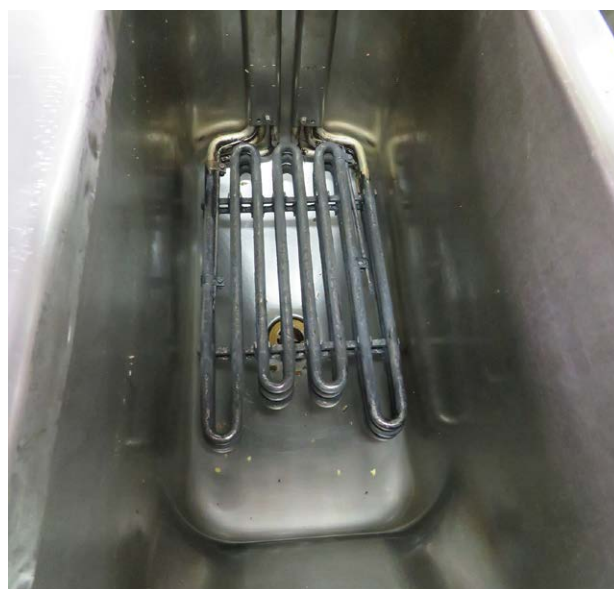
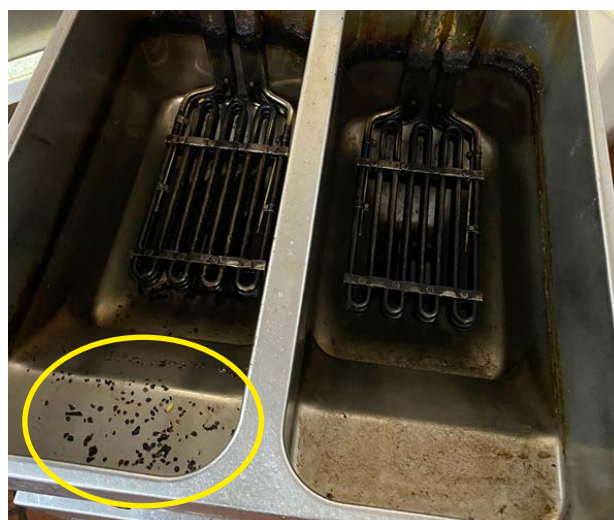
The crew raised the alarm and used a fire blanket to quickly smother the flames. The ship's emergency team mustered, isolated the galley's power and ventilation supplies and confirmed the fire was successfully extinguished. No one was injured in the incident and there was no damage to the ship. The two deep fat fryers had been drained of oil for cleaning and the cause of the fire was found to be residual food scraps saturated with fat that had ignited when the fryers were switched on.

Figure: A clean deep fat fryer (top) and the deep fat fryers with residual food scraps (bottom)

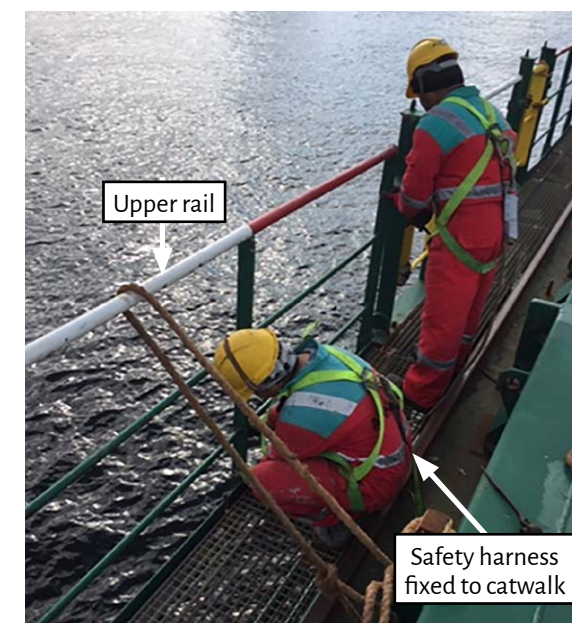
The 2/O was leaning towards the unsecured rail when it suddenly started to fall outboard. The 2/O, who was not wearing a safety harness fixed to the catwalk, lost their balance (Figure 2) and fell about 3.5m to the concrete quay below. The 2/O was in hospital for more than 10 days, having broken both legs in an attempt to land on their feet.

Figure 1: Bolts being removed from a section of upper rail

1. **Procedure** → The shipboard risk assessment for this task required anyone working aloft or over the ship's side to wear a fall arrester. Following safety procedures increases the opportunity to identify hazards and determine what equipment or control measures are needed to mitigate them and keep people safe.
2. **Equipment** → A safety harness and appropriate restraint tether would have prevented the fall. Personal protective equipment (PPE) may be deemed uncomfortable to wear and will likely require adjusting to allow you to work effectively, but it is essential when carrying out high-risk tasks such as working at height.

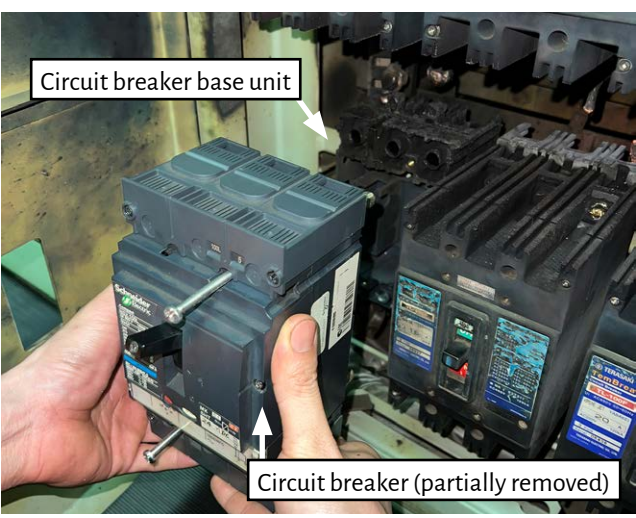
The circuit breaker was designed to be removed without the need to isolate the base unit (Figure 1); however, the electrician was unfamiliar with this arrangement and had loosened one of the live connections on the input to the base unit (Figure 2). The electrician used rubber gloves to insulate themselves from the live 440 volt (V) alternating current terminals when working on the connections.

Figure 1: The circuit breaker arrangement

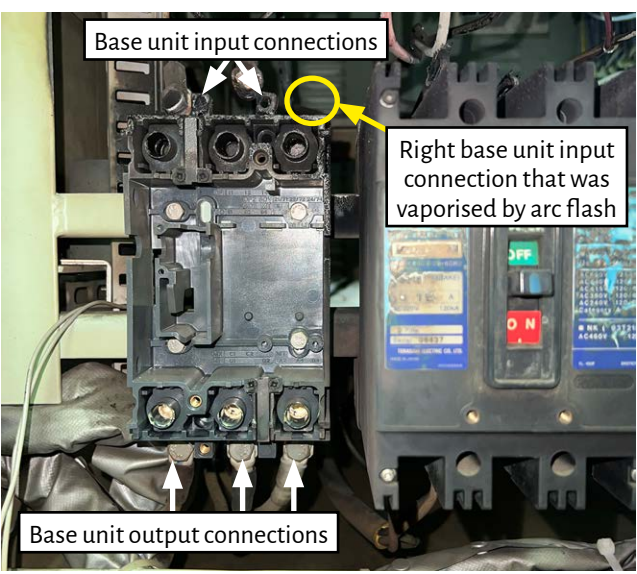
Figure 2: The base unit connections

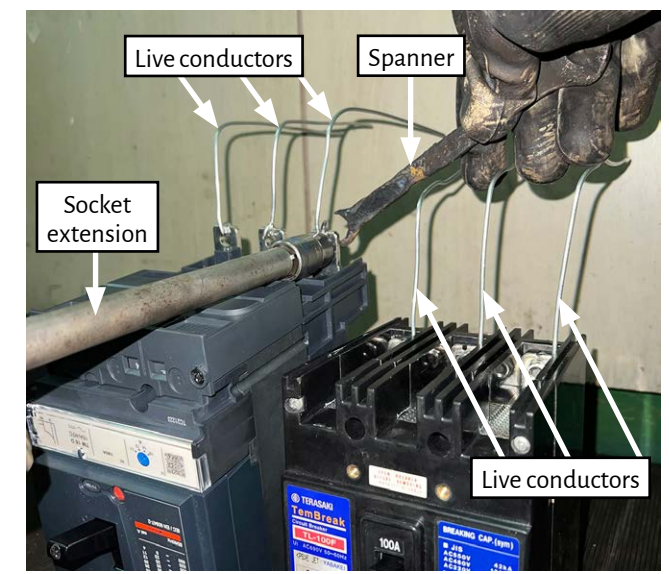
After the C/E left the engine room, the electrician tried to reconnect the cables to the base unit using a socket extension on the head of the bolt and a spanner to hold the nut in position at the rear of the connections. As the electrician tightened the bolt on the live input connection, the nut rotated and the steel spanner touched an uninsulated copper conductor on the adjacent circuit breaker base unit. This caused a short-circuit between two phases of the switchboard (Figure 3).

Figure 3: Reconstruction of the accident

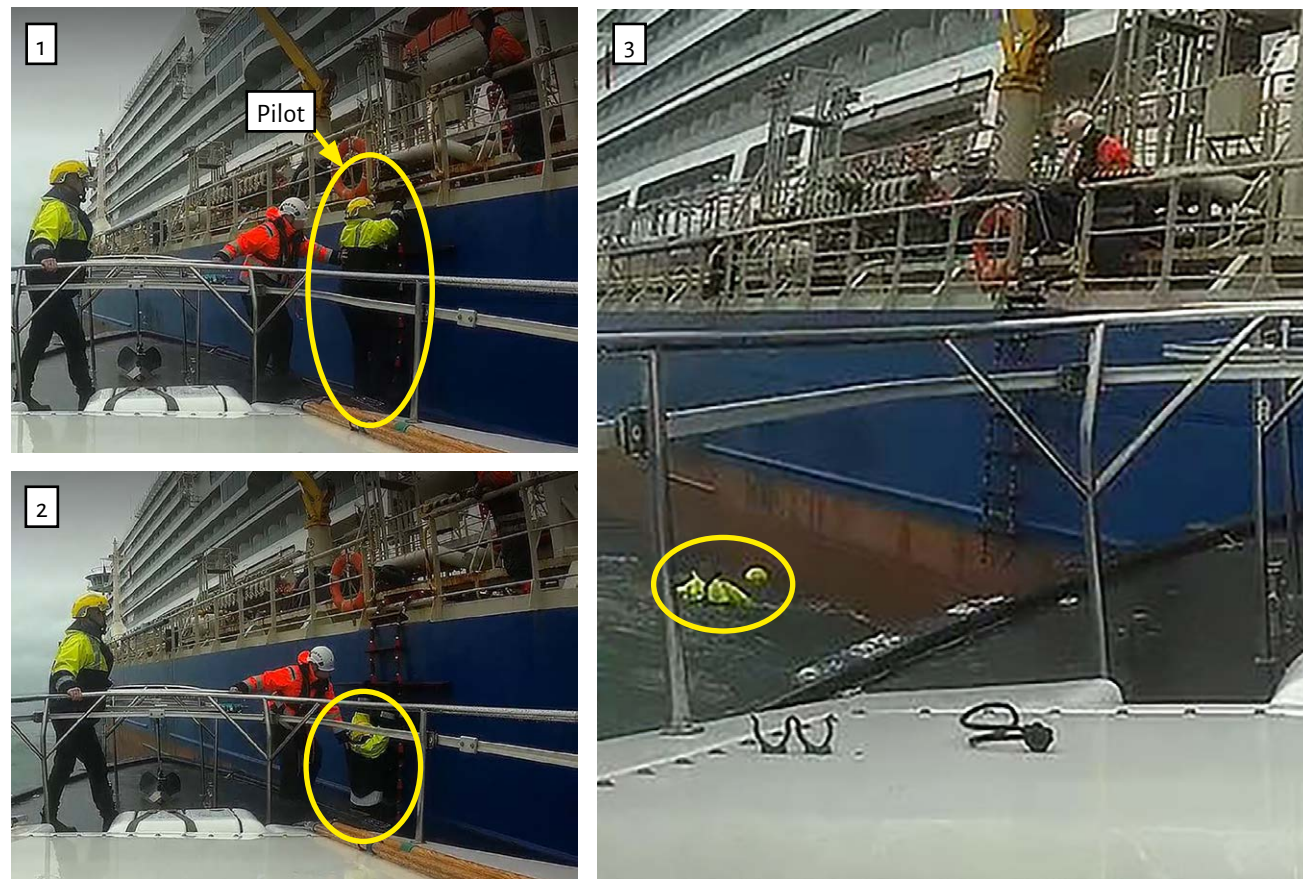
A pilot was embarking a moored bunker tanker via its pilot ladder in calm conditions. Once alongside the tanker, the pilot tested the ladder and then stepped onto it. As the pilot began to climb, the ladder suddenly dropped by over a metre and the pilot fell from it into the water (Figure 1).

Figure 1: The fall sequence

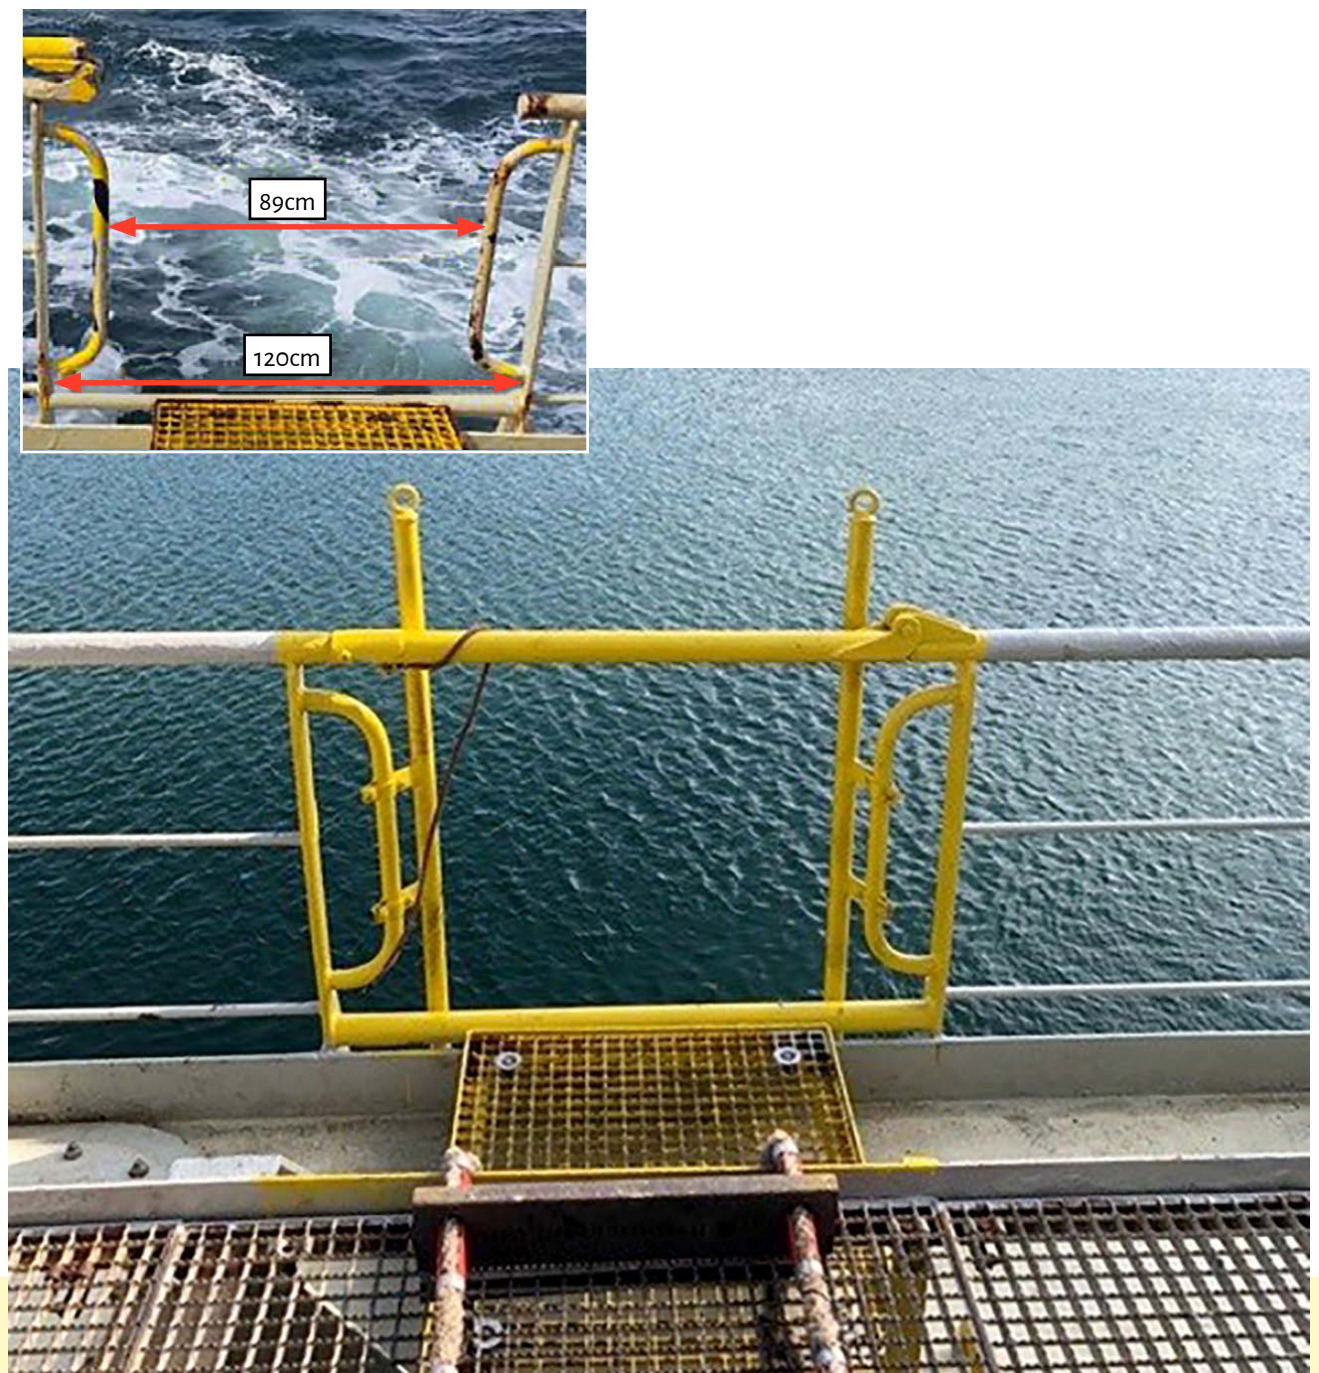
Figure 2: Guard rail gate at the top of the pilot ladder before (inset) and after modification to make it compliant

- Check** → A responsible officer must check that the pilot ladder is correctly rigged and ready for use before the pilot boards. In this case a rung of the pilot ladder had become caught on a deck fitting and when the pilot put their weight on the ladder it unexpectedly dropped, causing them to lose their handhold and fall into the water.
- Equipment** → A post-accident inspection of the tanker's pilot boarding arrangements found that the tanker's guard rail handholds were more than 80cm apart and its boarding arrangements were therefore assessed as noncompliant with SOLAS<sup>1</sup> regulations. Figure 2 shows the arrangements at the time of the accident and after the owner's modifications to provide compliant handholds.

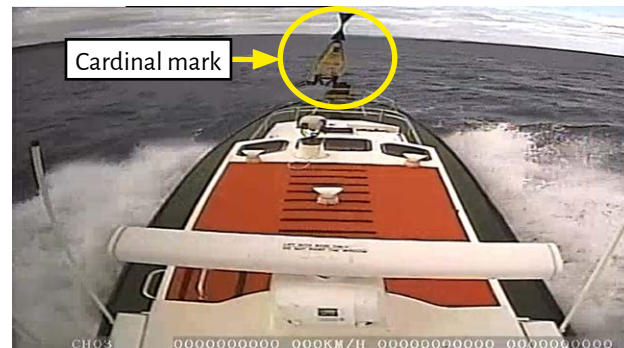
The pilot vessel struggled to maintain 12kts at full throttle on its passage back to the pilot station, which was later found to be due to an issue with the starboard fuel pump that occurred during the collision.

Figure: The pilot vessel colliding with the cardinal mark

- Check** → The decision not to check for damage after the collision and proceed undeterred put the crew, vessel and disembarking pilot at risk. It is natural to feel embarrassed after an accident and perhaps want to sweep it under the carpet, but early communication can prevent escalation of the situation. The crew of the pilot vessel were very lucky to avoid a more serious outcome.

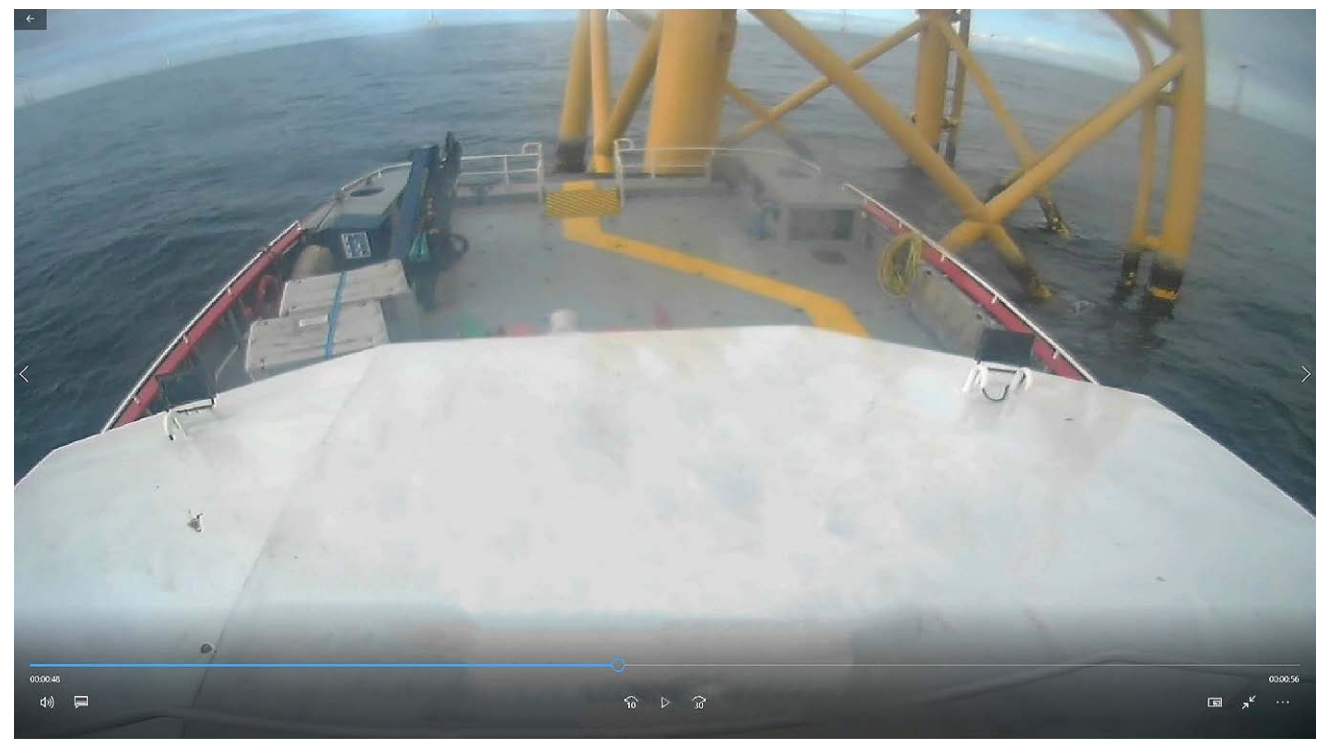
Figure 2: The moment the workboat bow collided with the wind turbine tower platform

The workboat took the brunt of the impact on its off-centre protected bow section (Figure 2) and unsecured items were thrown forward across the deck as the vessel came to a jolting standstill. The crewman was thrown against a shelf and sustained two broken ribs. The master assessed the crewman's injury and the damage to the

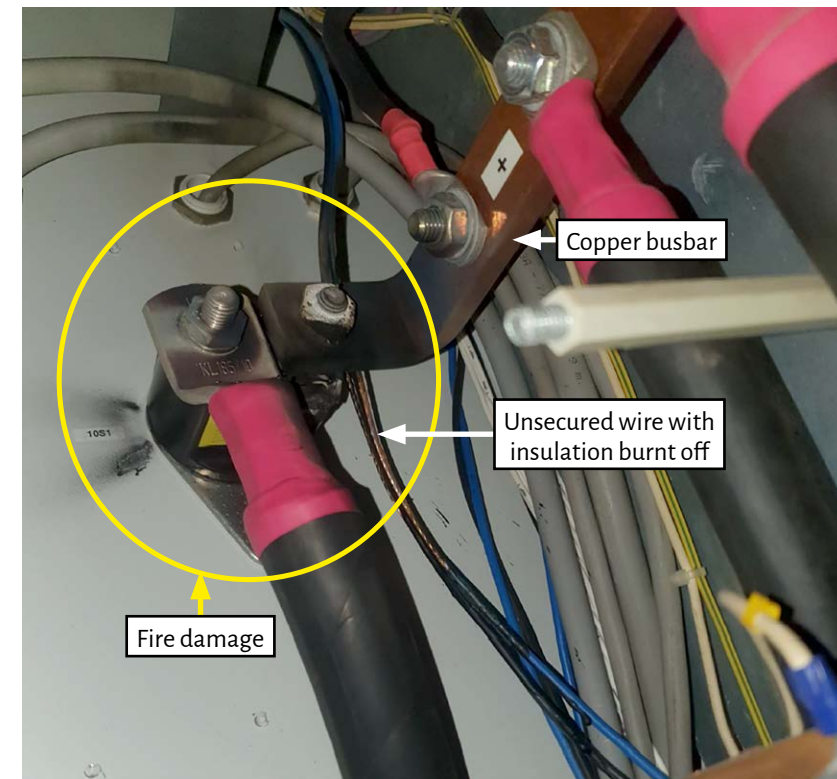
The cause of the fire was traced to an unsecured wire inside the 24V DC control panel, which was touching the copper busbar that supplied starting power to the main engine. Over time, vibration

had caused the insulation surrounding the unsecured wire to wear through until the wire's conductor made contact with the busbar. The powering up of the circuit caused a short-circuit and conducted a massive current. The circuit breaker protecting the system opened and interrupted the circuit when the master pressed the start button, and this was repeated when the engineer reset it and tried to start the engine again. The unsecured wire was not designed to withstand such a high current even for a short time and rapidly heated up, burning away its remaining insulation and starting a small fire (Figure 1).

Figure 1: The burnt wire

The tug owners arranged a check of all control cabinets and any identified loose wires were properly secured.

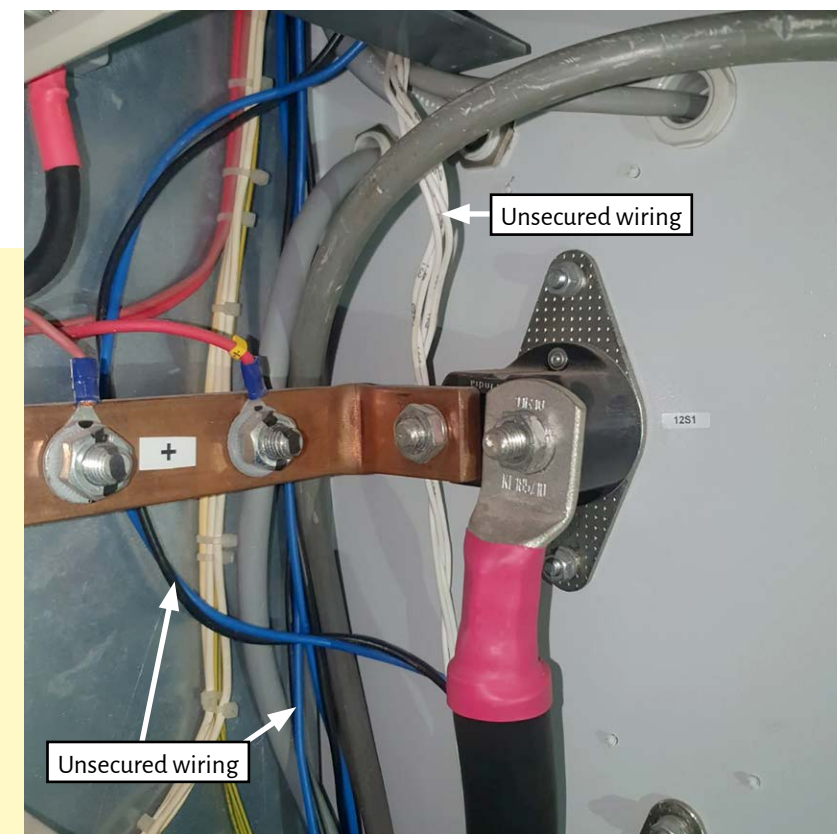
An inspection of the 24V DC control panel found several other unsecured wires (Figure 2), demonstrating that the risk remained for a similar event to happen again.

Figure 2: Unsecured wiring in the electrical control panel

3. **Action** → During inspections of electrical panels engineers should be aware of the risk posed by poorly supported wiring and loose connections and take appropriate action to reduce it to a safe level: find it, isolate it, secure it.

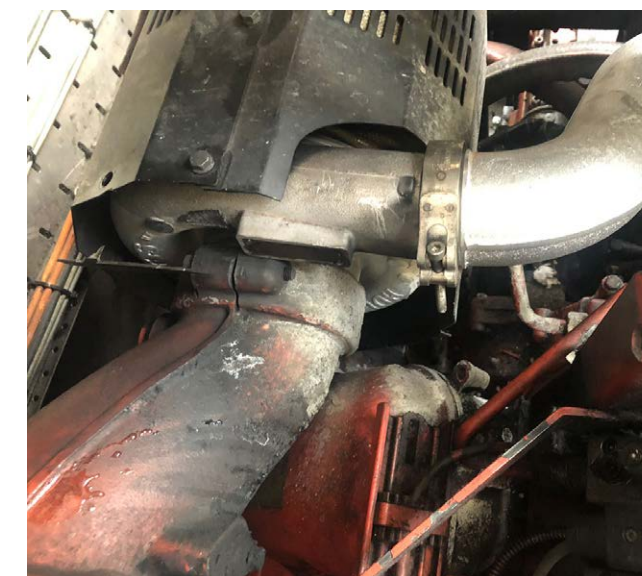
Figure 2: The seat of the fire (glowing orange)

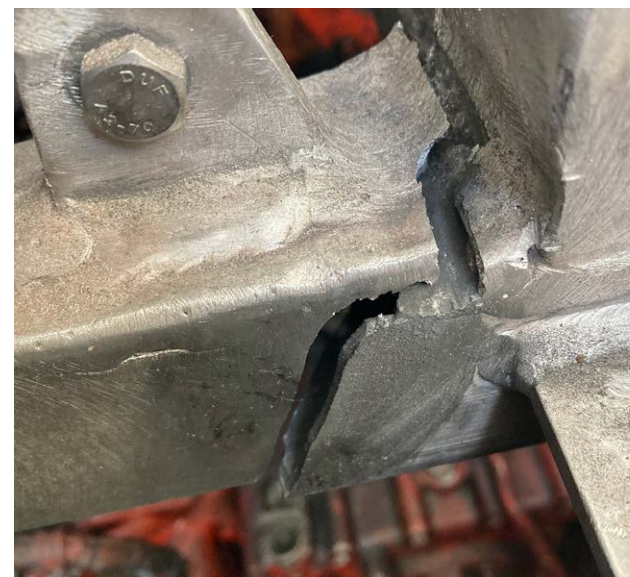
The turbocharger inlet had become fractured by excessive movement of the engine on its mounts. This had happened over time because the engine's fixed stays and some support brackets had sheared off through vibration and stress (Figure 3).

Figure 3: Fractured engine support

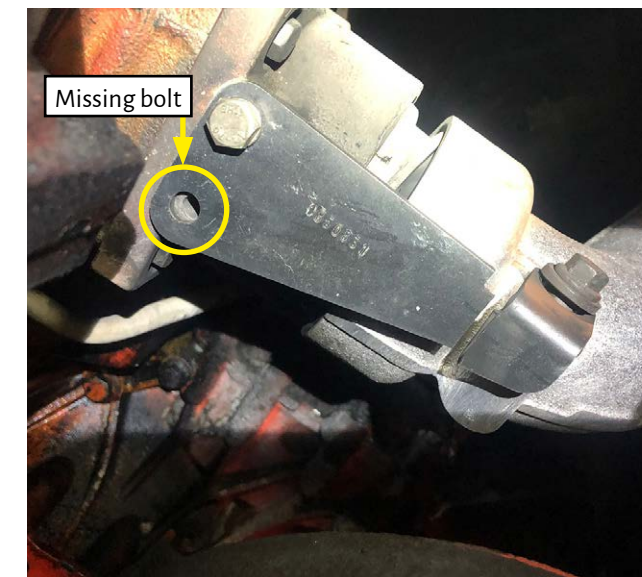
Figure 4: Fractured bracket and missing bolt

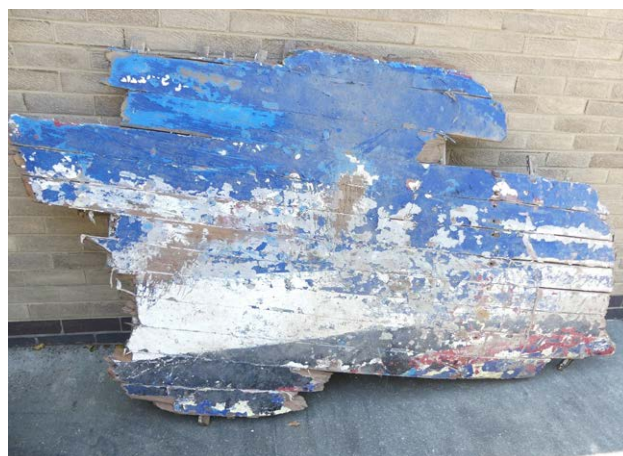
Figure: Recovered hull section

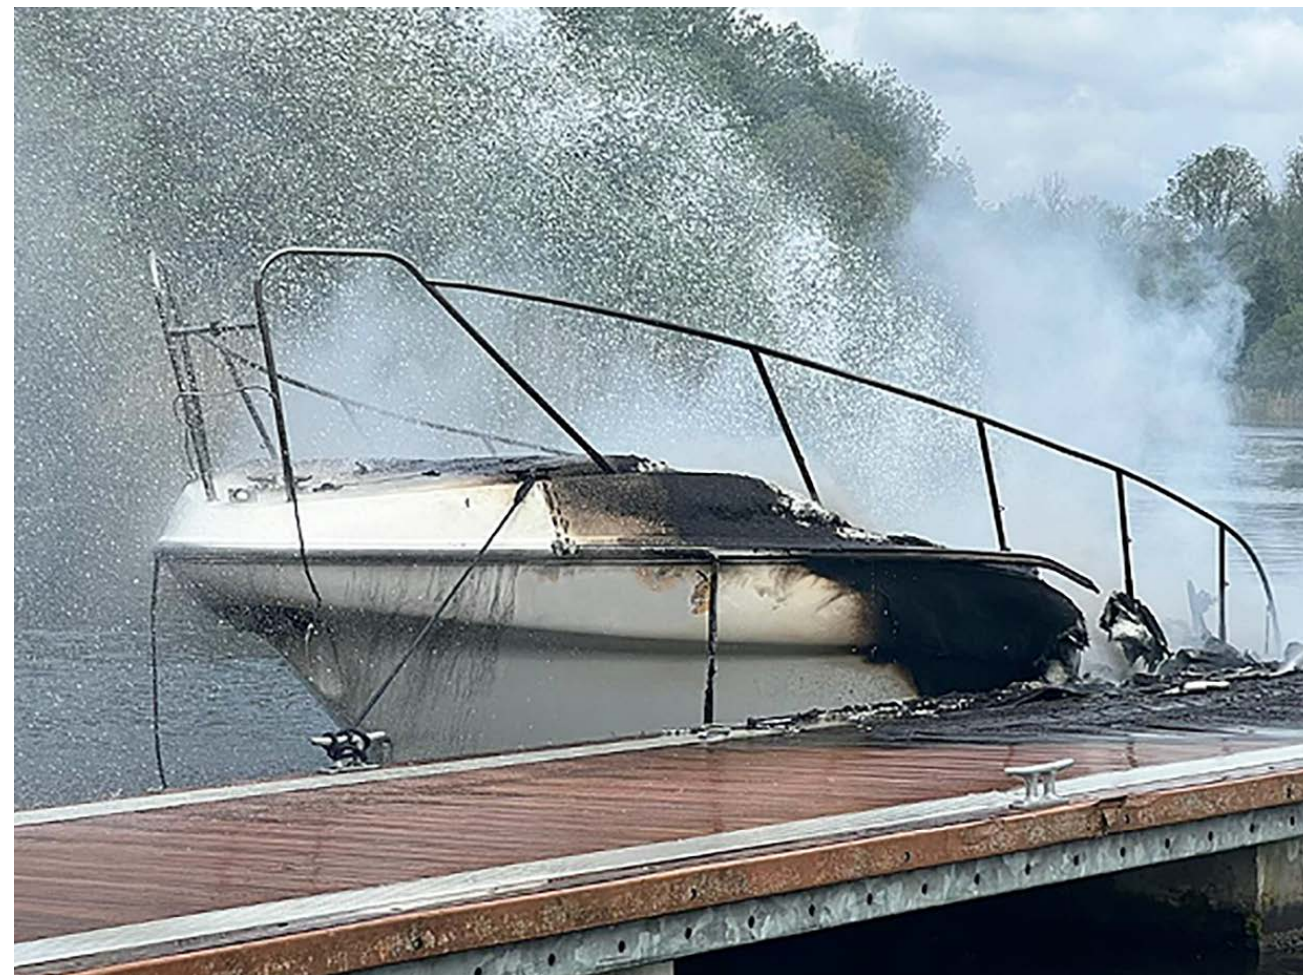
and evacuated to hospital by helicopter, having suffered significant burns from which they were lucky to survive. Tragically, both dogs perished in the accident. The fire-ravaged motor yacht (Figure 2) later sank to the bottom of the loch.

Figure 2: The burned-out motor yacht just before it sank

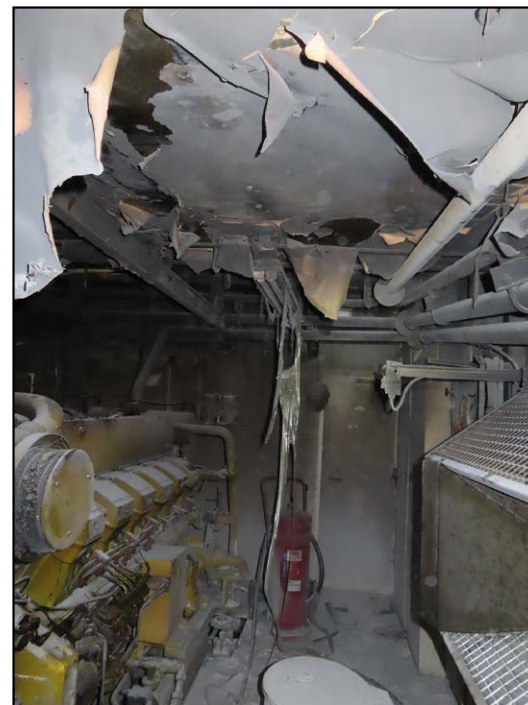
*Finnmaster's* fire-damaged compartment

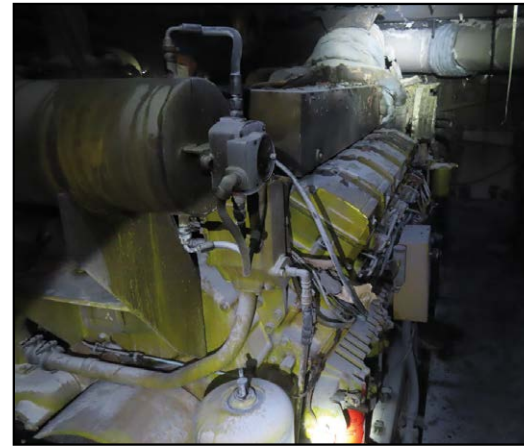
**Figure 1:** Damage sustained to auxiliary engine room

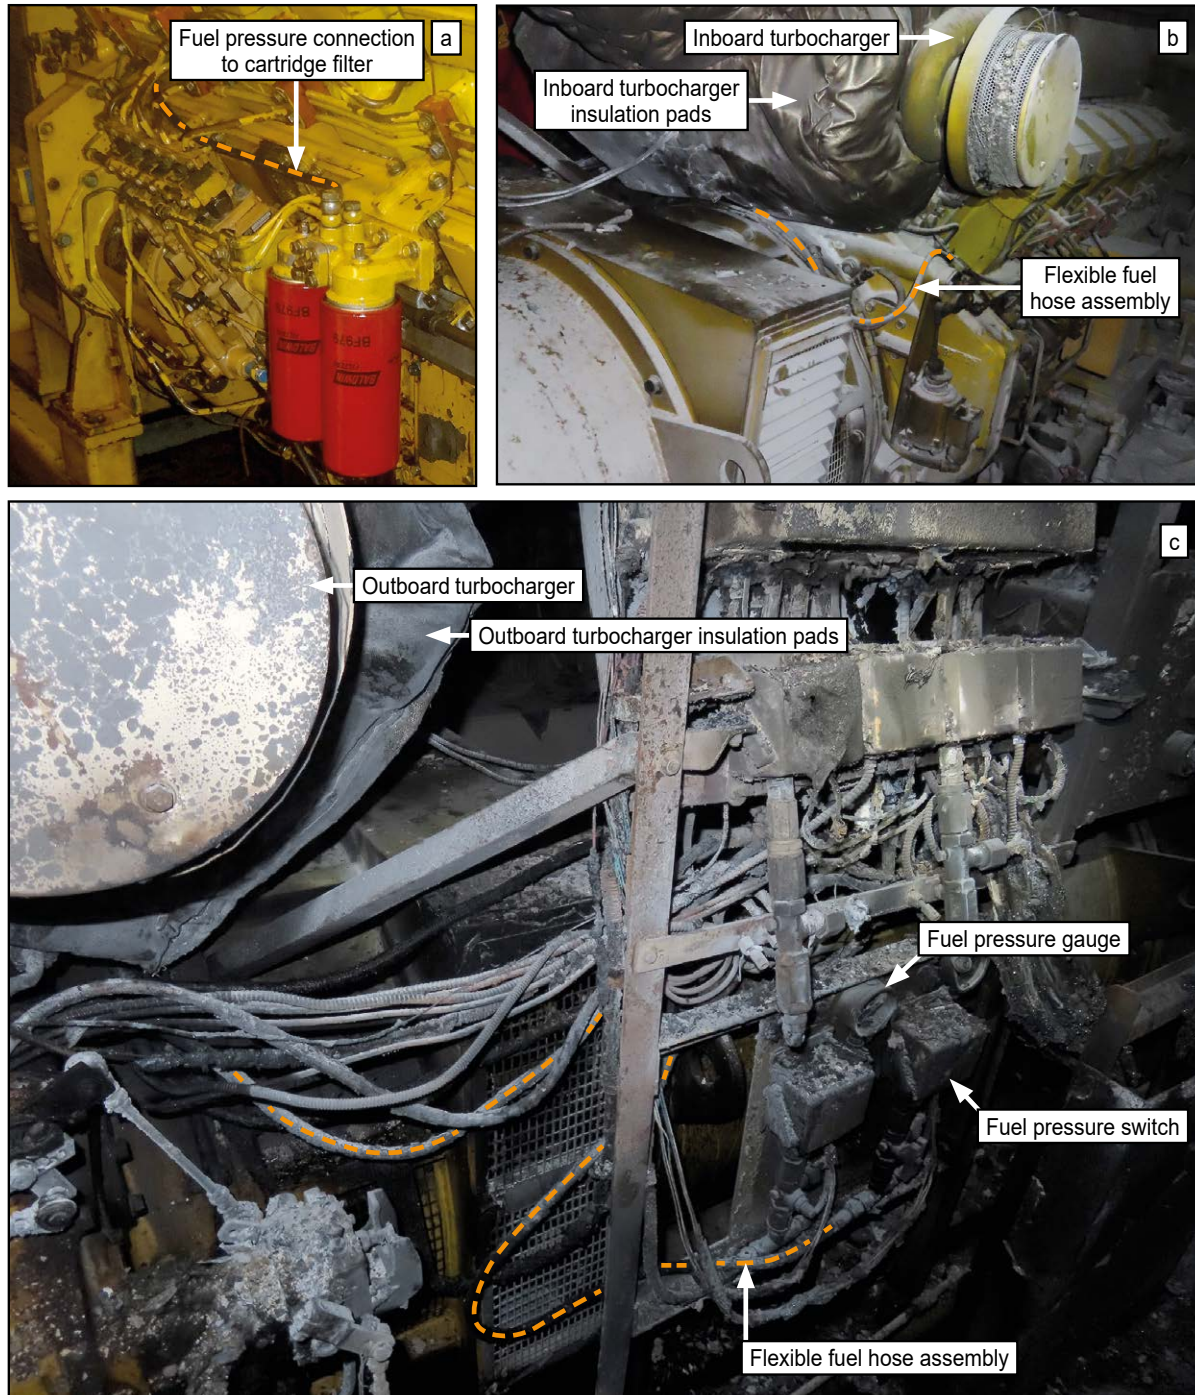
The IMO guidance on flexible hose installations, including the limitation of length, were incorporated into the rules of the two classification societies that provided oversight of *Finnmaster* during the period that the flexible hoses were in place on the vessel.

**Figure 3:** Small-bore flexible fuel hose assembly on AE2, as indicated by dashed orange line

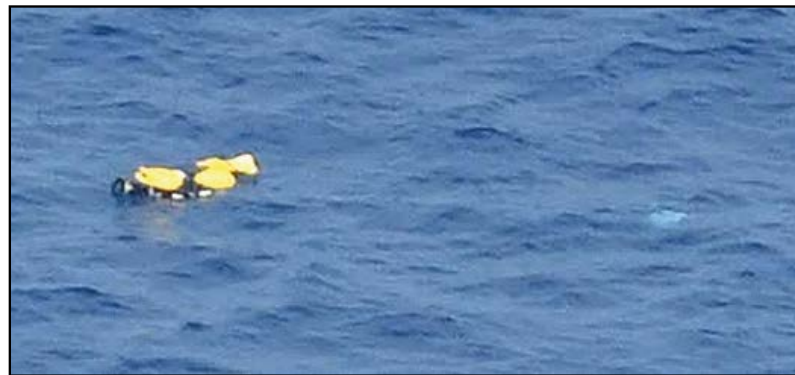
It was not possible to determine the cause of the port liferaft's failure to deploy correctly, as it was not recovered after the accident. It was last observed drifting in an inverted orientation, having apparently released from its canister and partially inflated (**Figure 1**).

**Figure 1:** The port liferaft, floating inverted and partially inflated

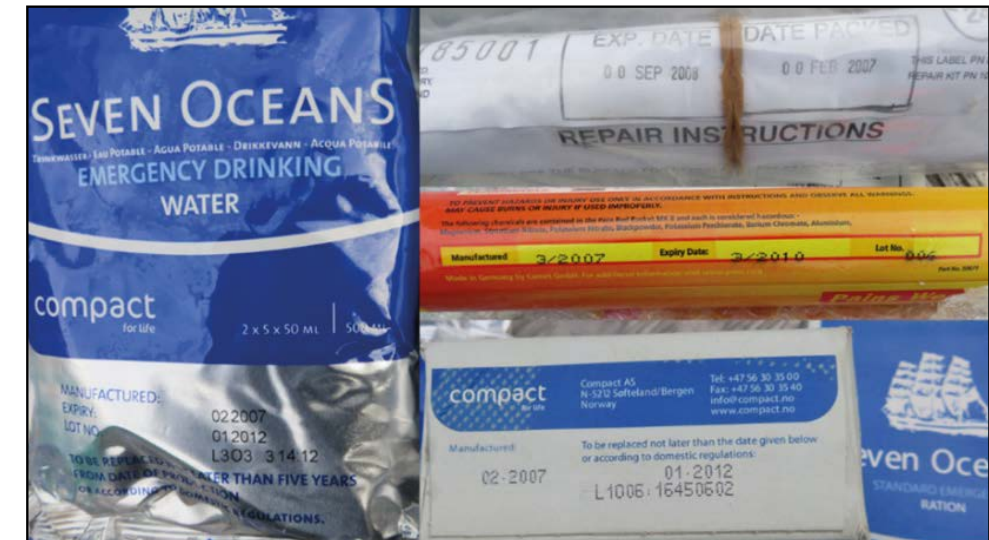
- the torch batteries had expired in January 2010;
- all of the pyrotechnics had expired in March 2010; and
- all of the food and water supplies had expired in January 2012.

**Figure 2:** Examples of the expired consumable items in *Piedras*'s starboard liferaft
