SAFETY DIGEST

Lessons from Marine Accident Reports

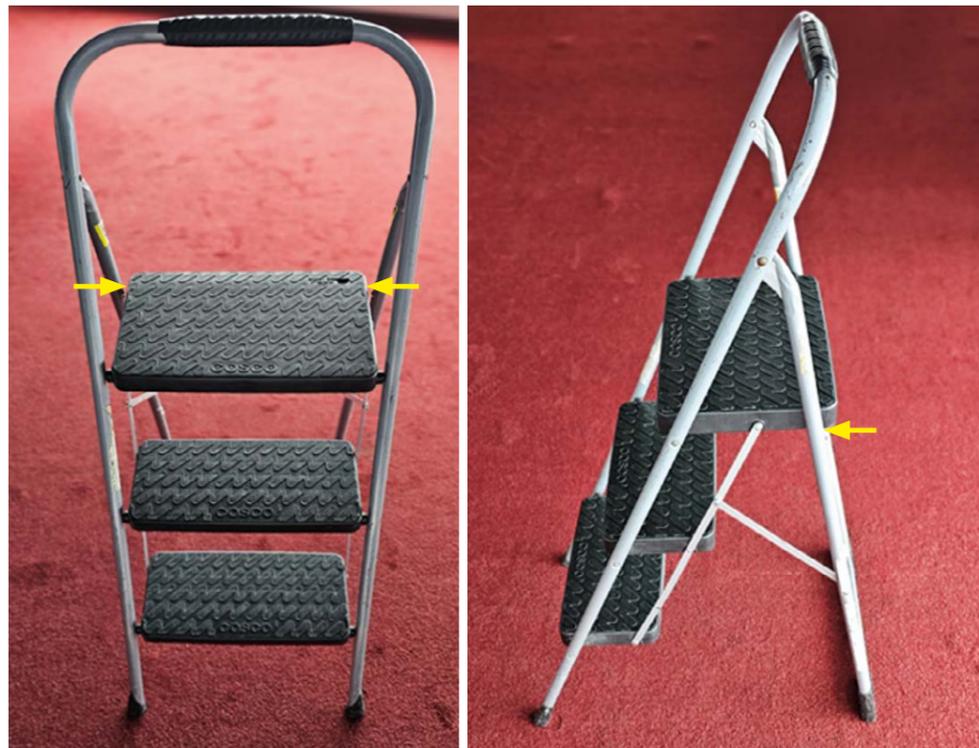
Figure 1: The stepladder, showing the location of the failed metal support

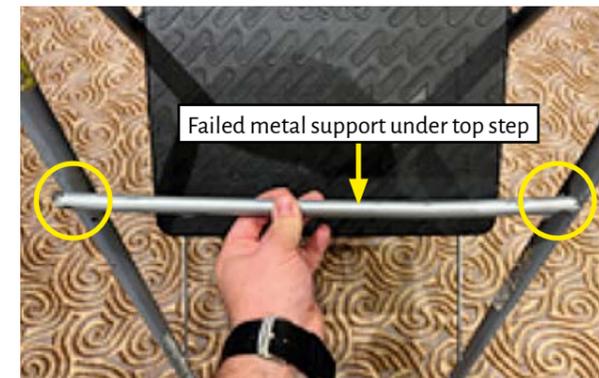
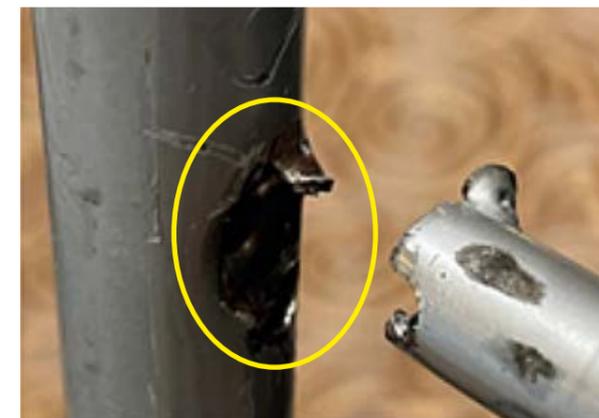
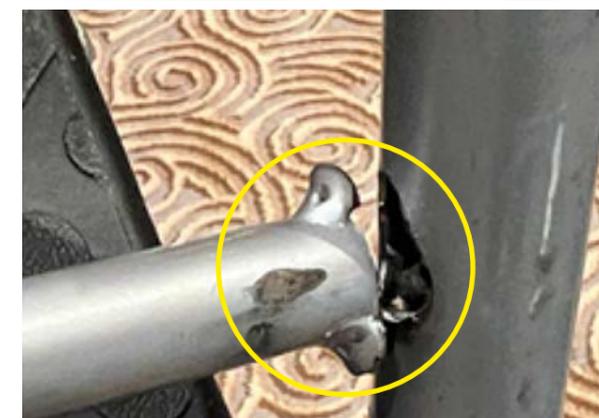
Figure 2: The points of failure and damage

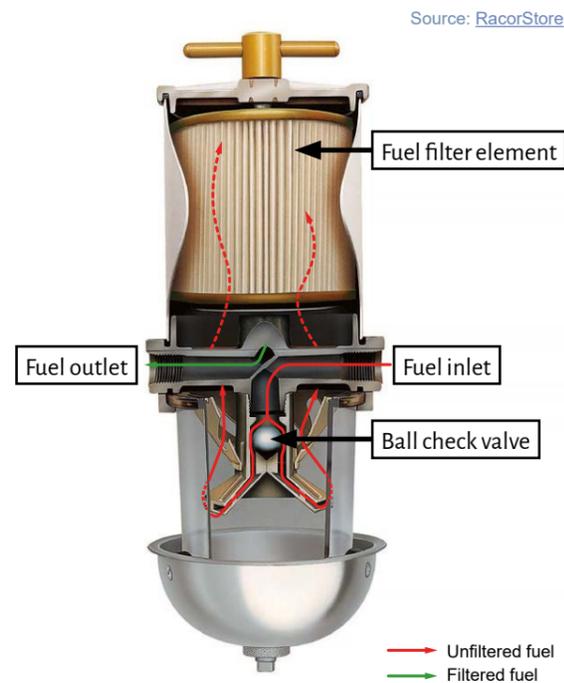
Figure: Fuel flow through the filter

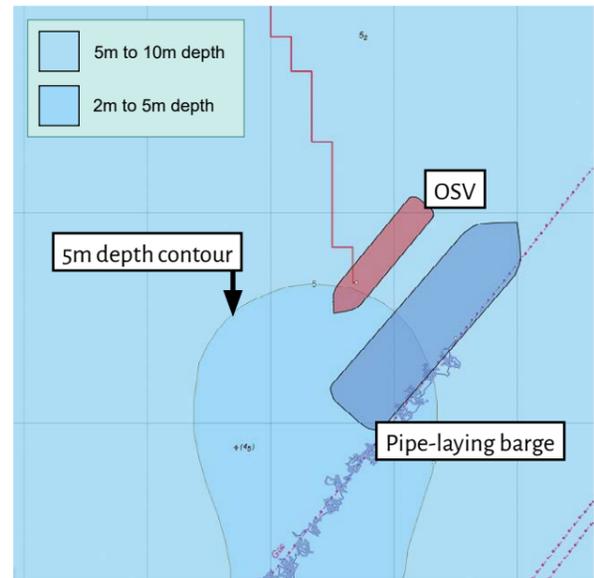
Figure 1: The OSV crossing the 5m contour on approach to the pipe-laying barge

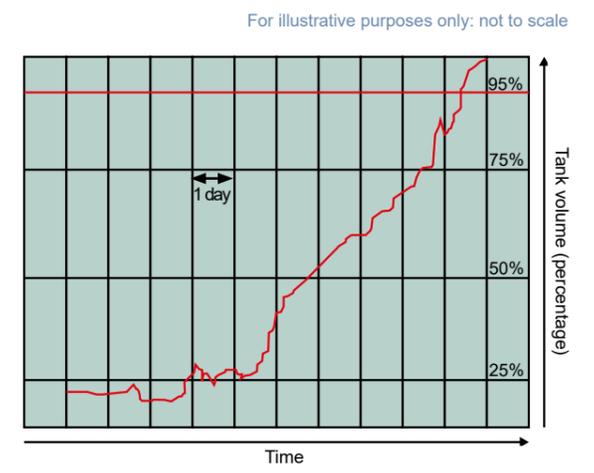
Figure 2: Tank sensor trend data, showing the tank slowly filling up over 9 days

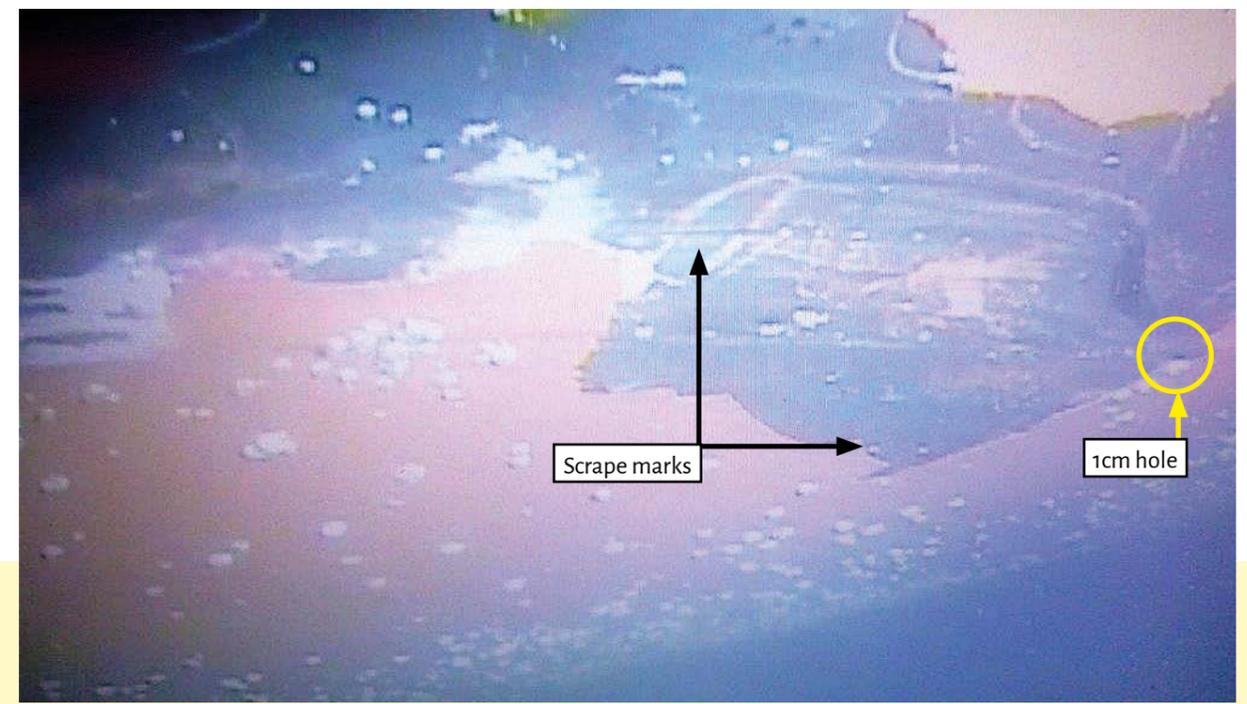
Figure 3: Damage to the hull

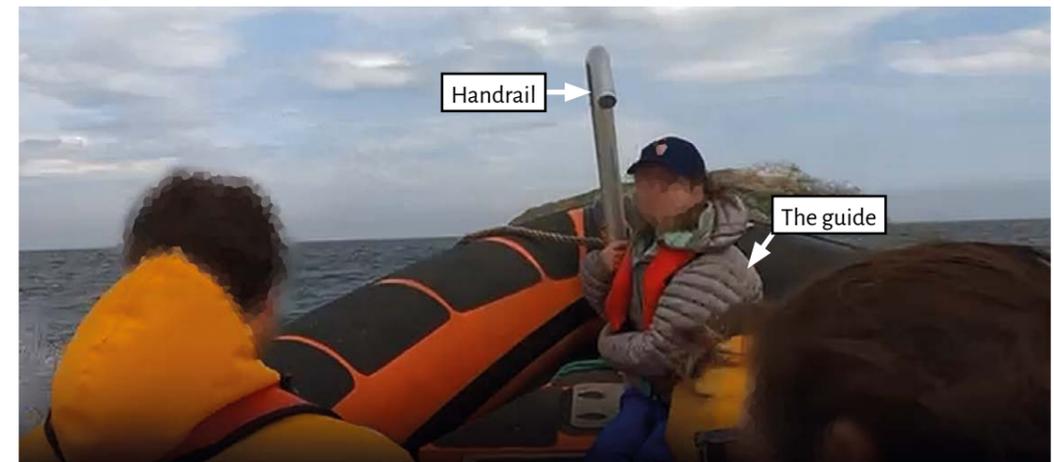
Figure 1: The guide's seated position in the RIB's bow

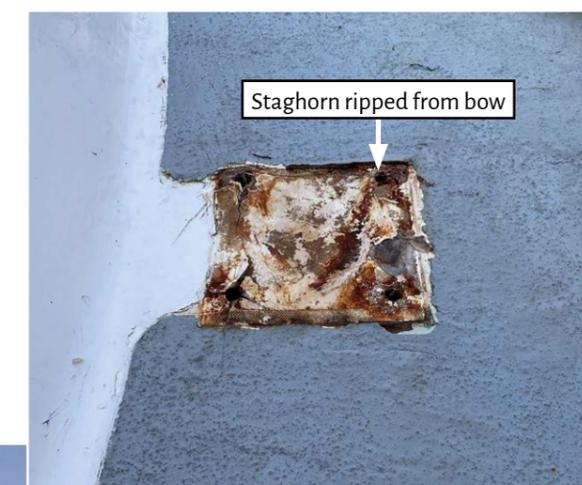
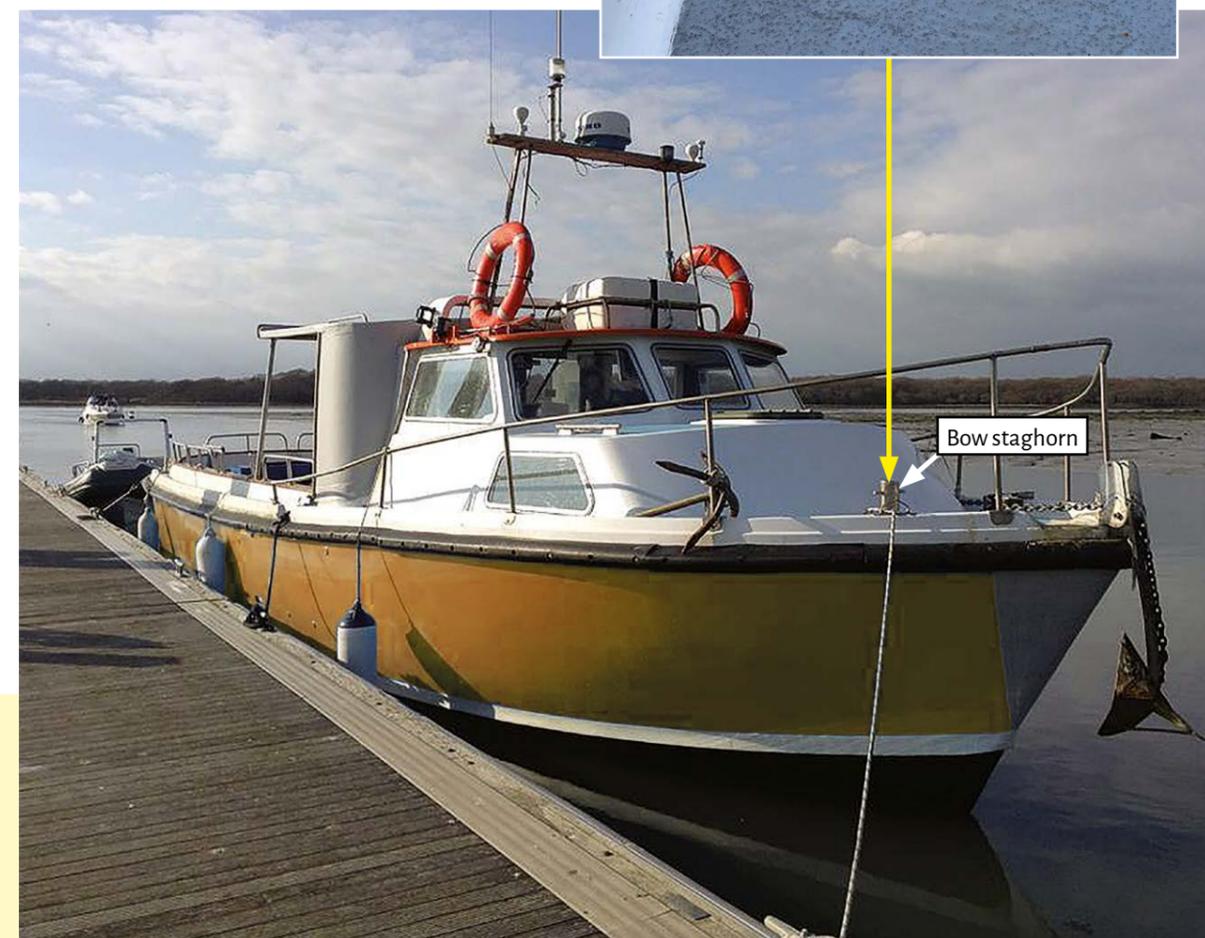
Figure: Bow staghorn on the charter angling vessel

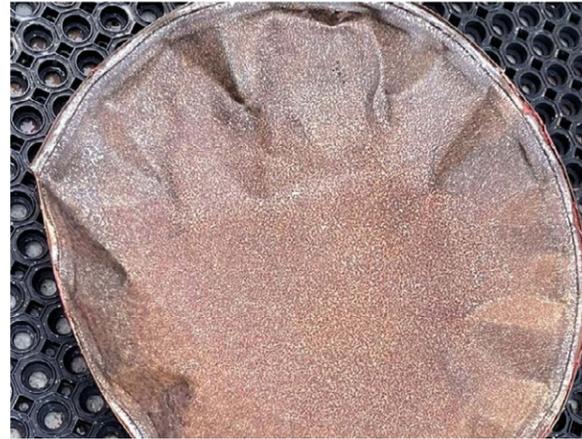
Figure: The base of the steel oil drum

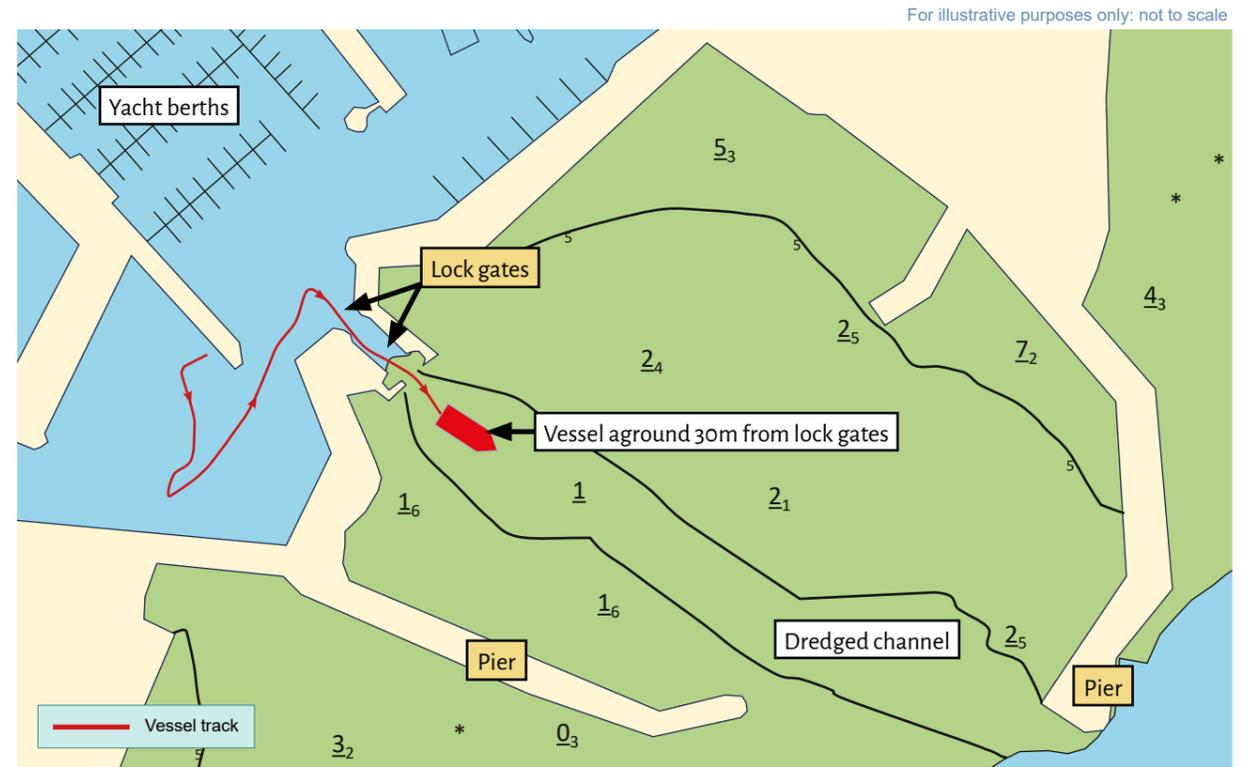
Figure 1: Vessel track and grounding

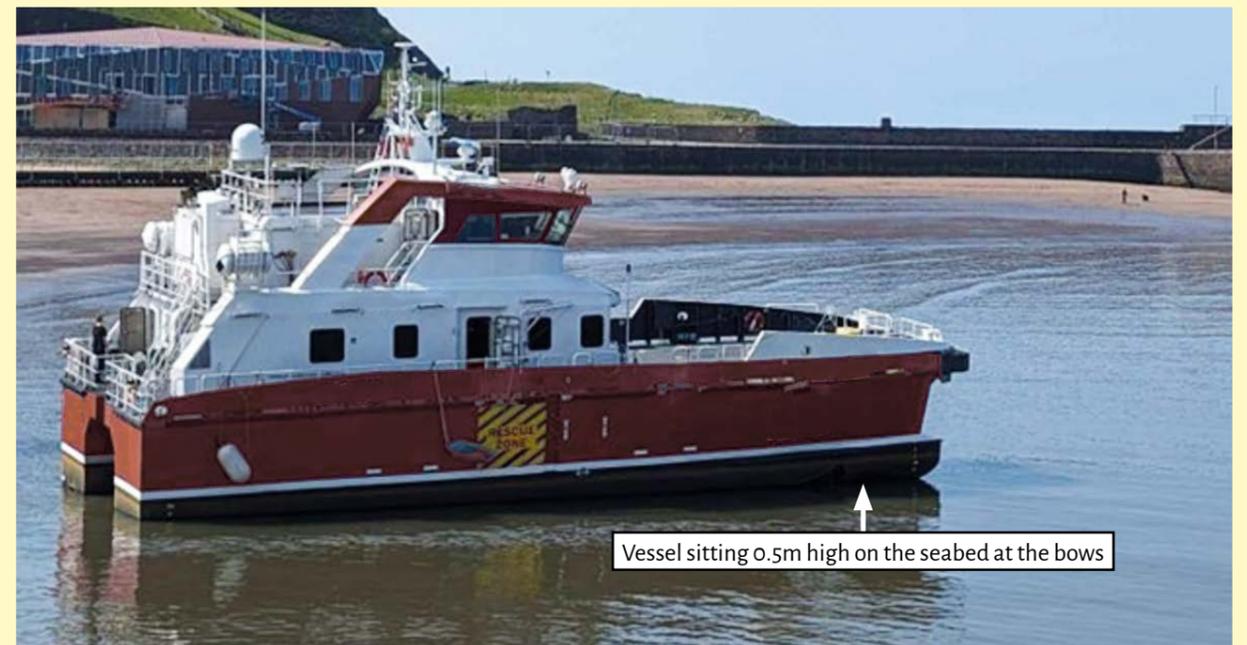
Figure 2: Vessel aground at low water

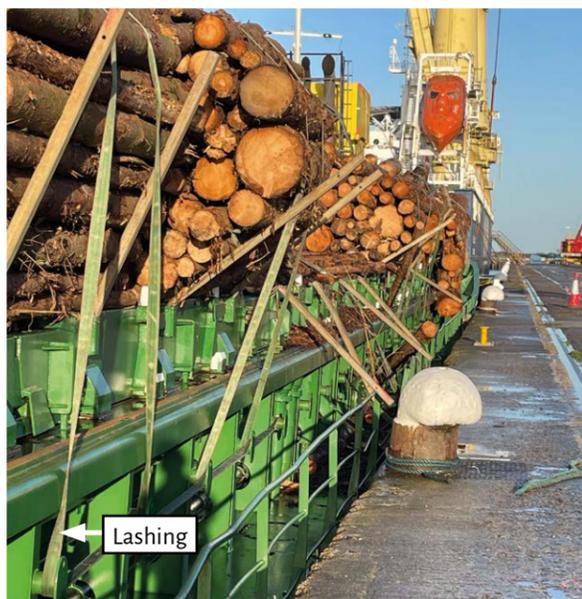
Figure 1: Failed log deck cargo lashings

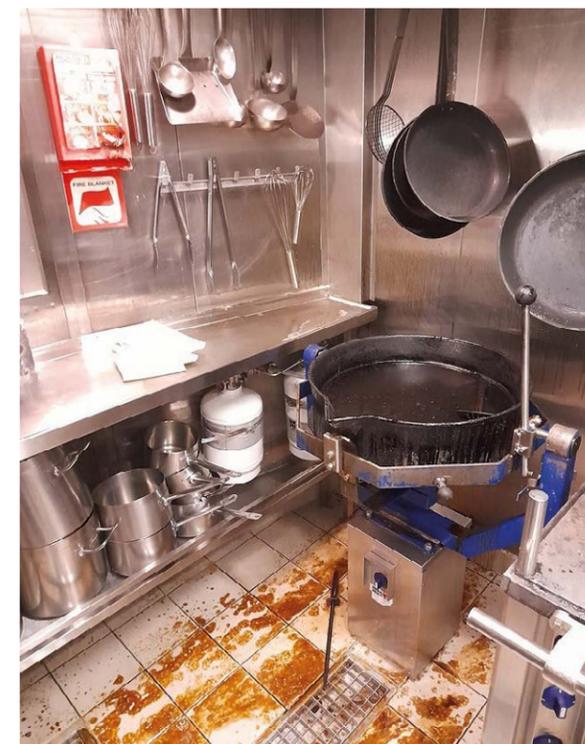
Figure: Cooking oil on galley deck

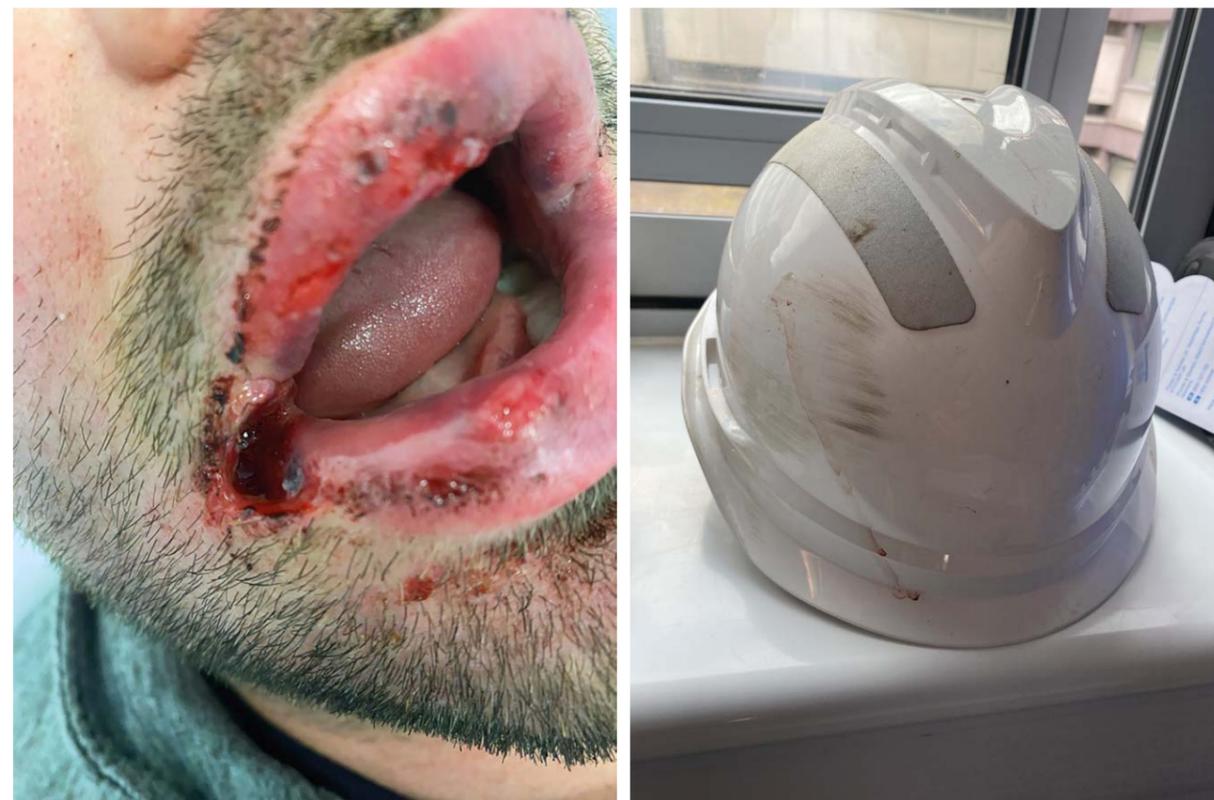
Figure 3: Some of the deckhand's facial injuries and damaged safety helmet

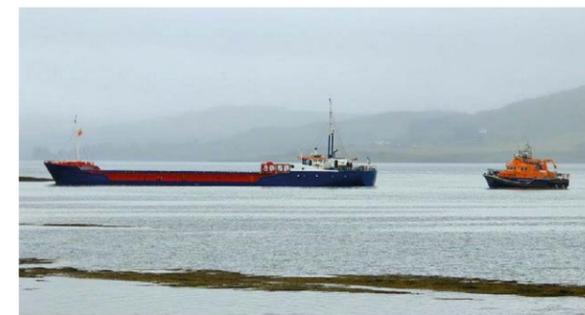
Figure 1: The vessel aground

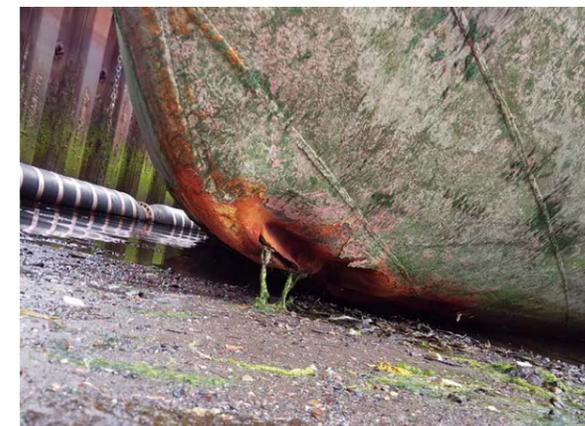
Figure 2: The cracked stem

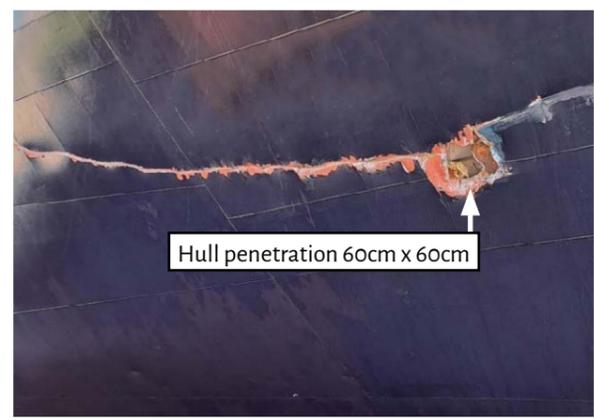
Figure 1: Damage to ship's hull

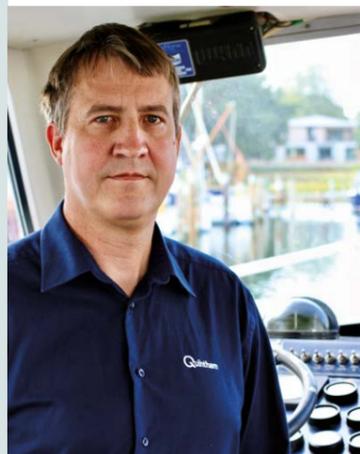
I have read the MAIB Safety Digest for many years and it is heartbreaking to read through this edition and see similar cases to the first editions I read in the mid-1990s. Where will the progress that the industry needs come from? This question has driven me throughout

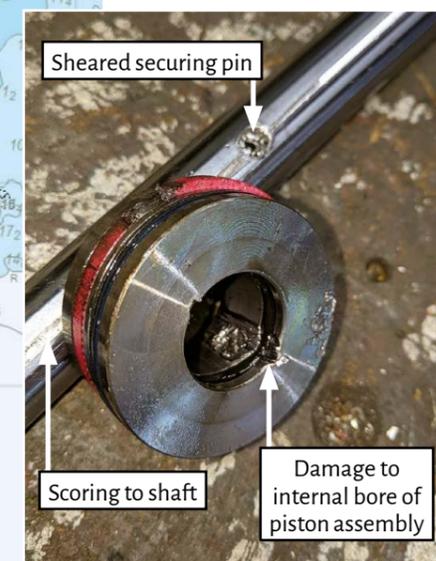
Figure 2: Failed steering gear actuator piston attachment

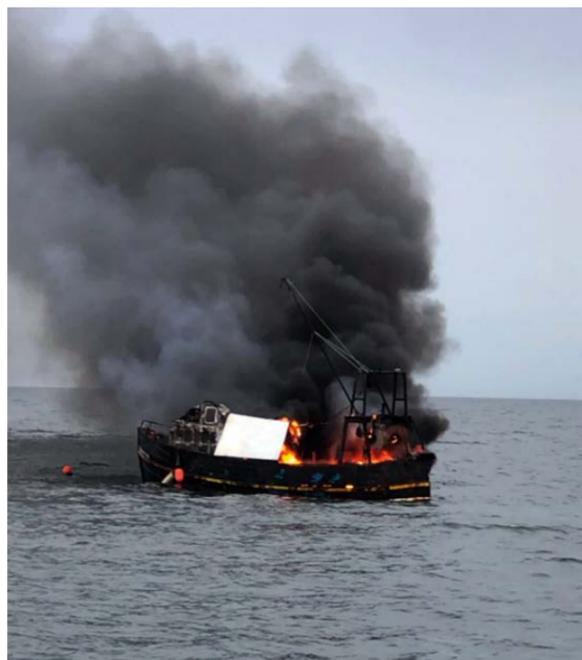
Figure 1: The fishing vessel on fire

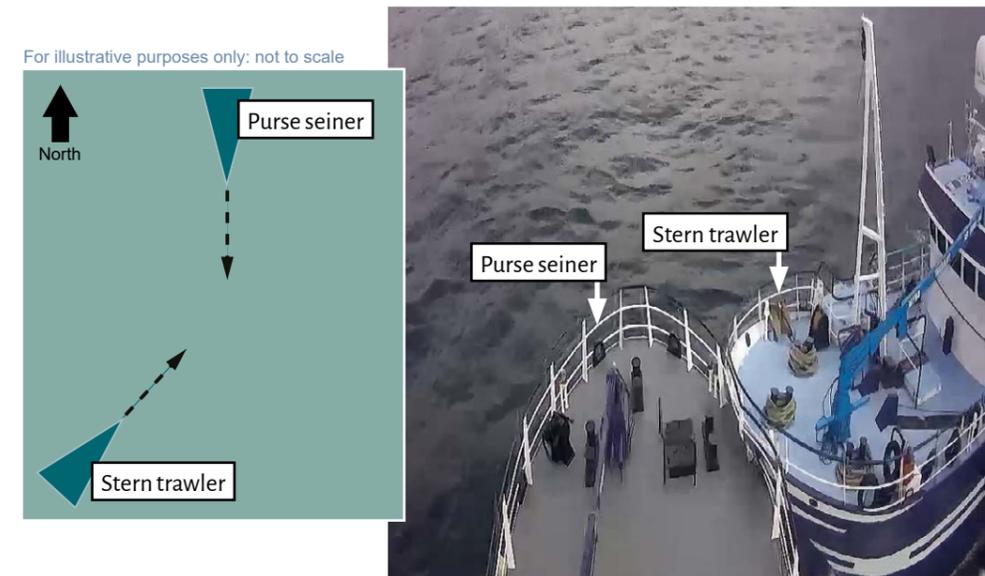
Figure 1: CCTV still of the collision and (inset) the relative positions of the vessels before it

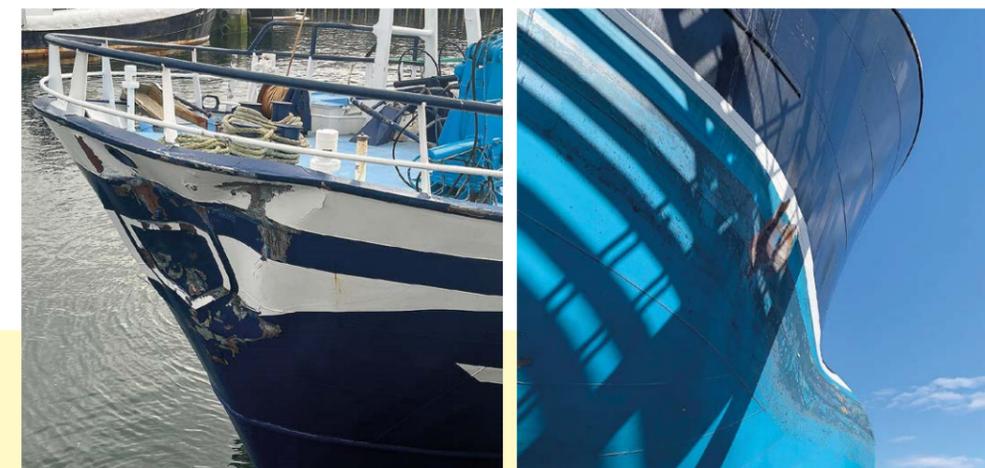
Figure 2: Damage to the stern trawler (left) and purse seiner (right)

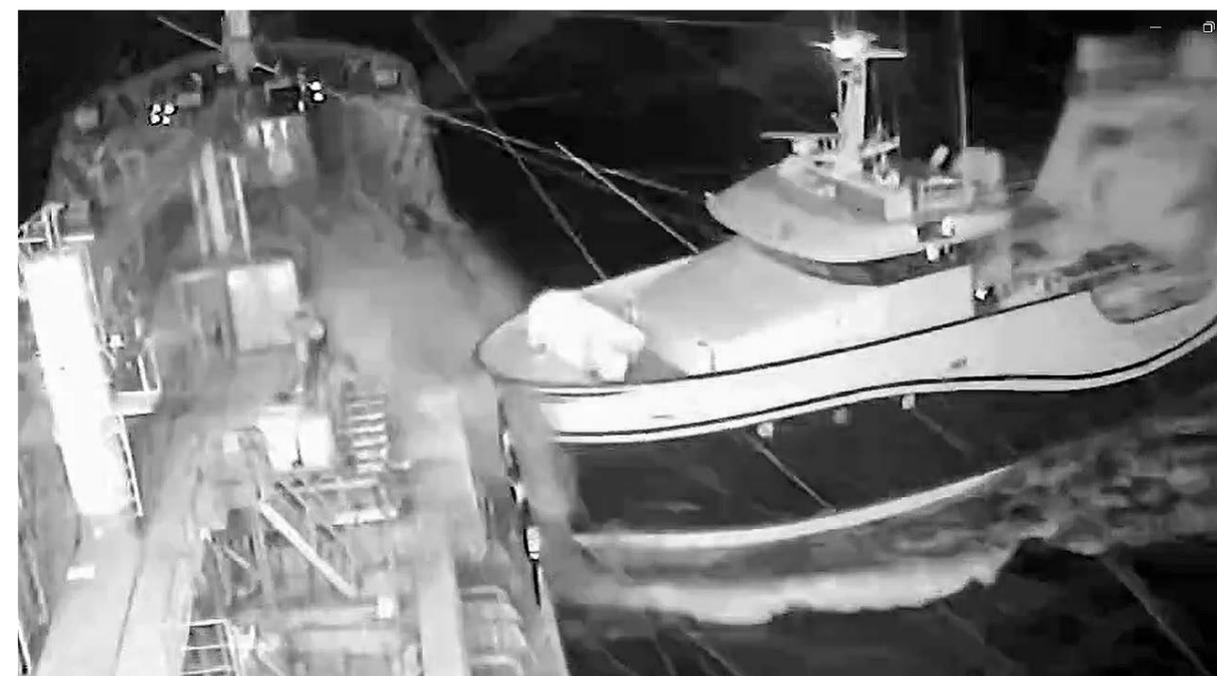
Figure 1: CCTV still of the fishing vessel colliding with the chemical tanker

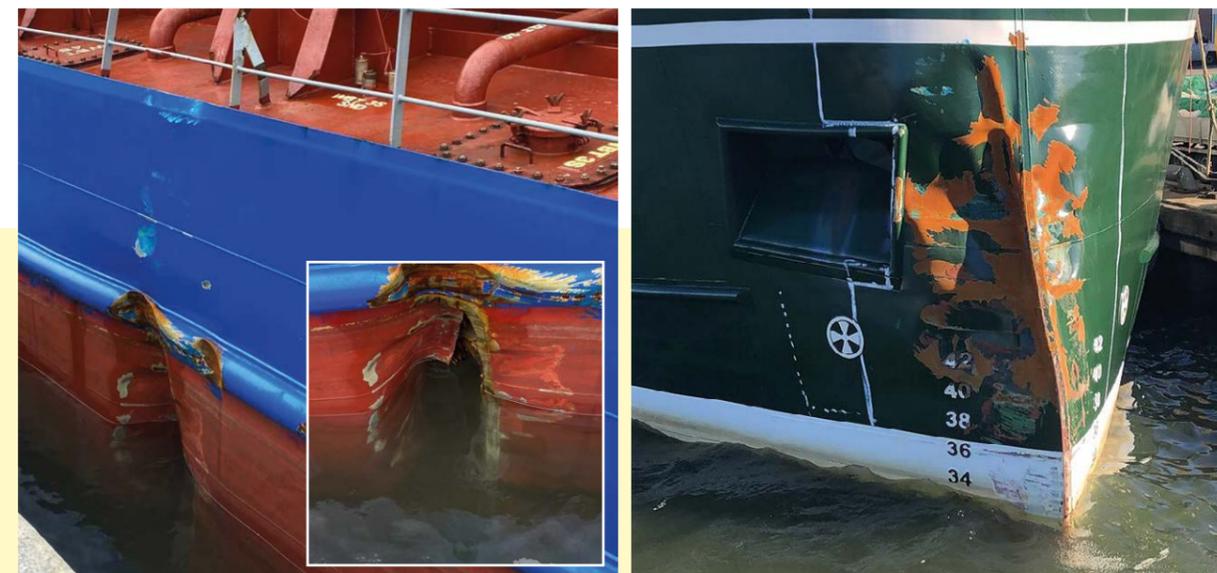
Figure 2: Damage sustained to chemical tanker (left) and fishing vessel (right)

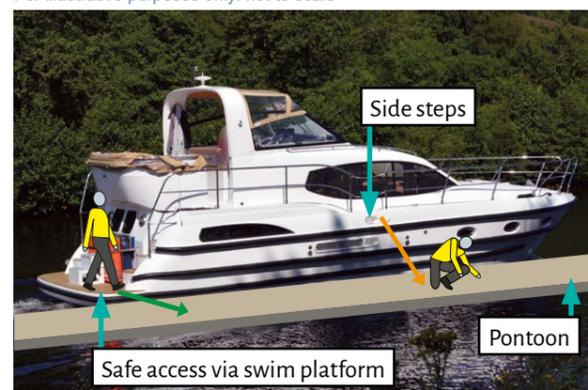
Figure: The fall location and safe alternative disembarkation route

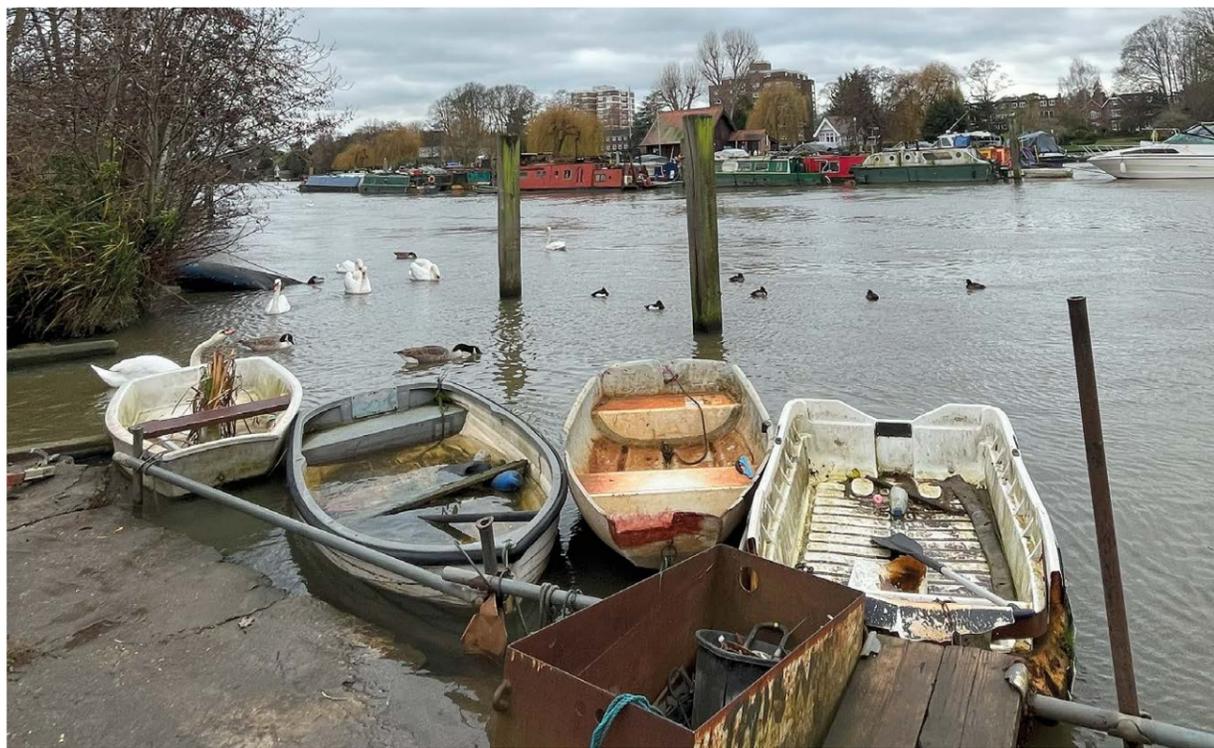
Figure 1: A typical dinghy

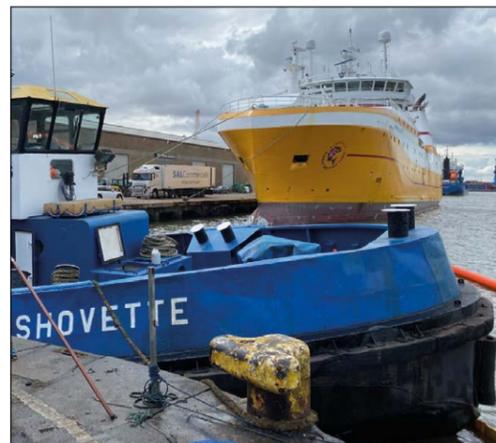
Kirkella and *Shovette*

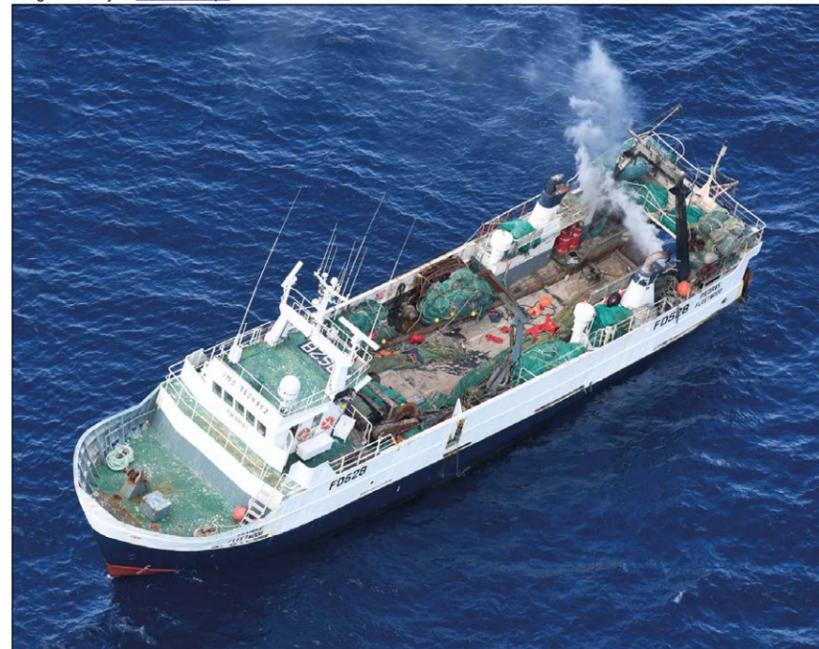
Image courtesy of [Irish Air Corps](#)

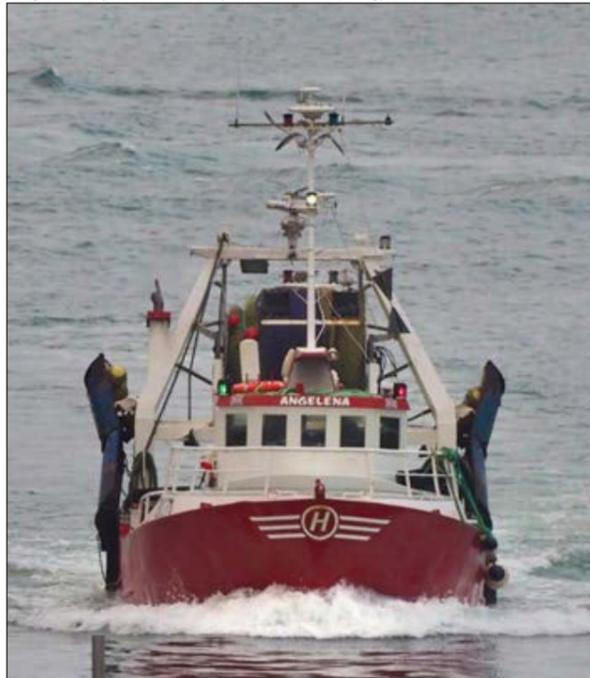
Image courtesy of Alan Letcher (<https://fishandships.org>)
