# SAFETY DIGEST

Lessons from Marine Accident Reports

2/2023

# MARINE ACCIDENT INVESTIGATION BRANCH

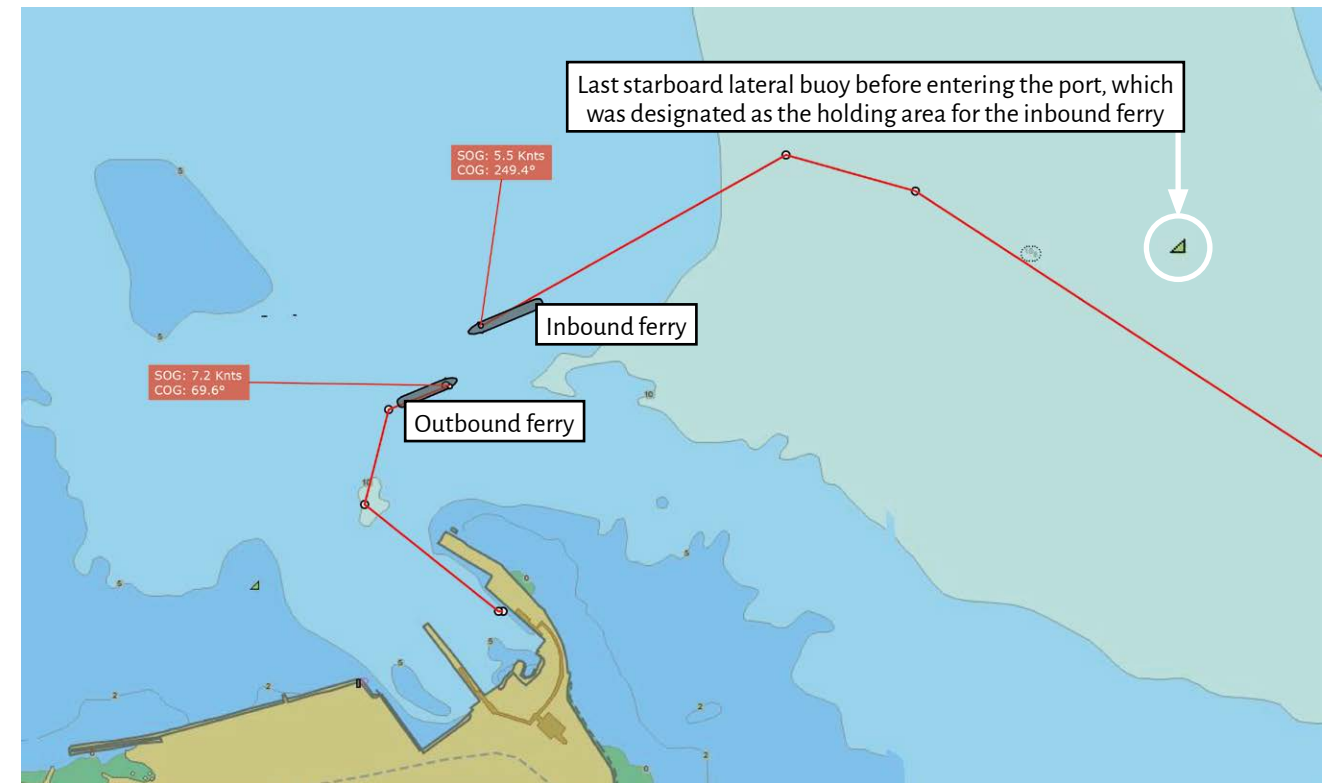
Figure 1: Chart reproduction, showing the tracks of the ferries and the position of the lateral buoy

Unaware of any conflicting traffic, the outbound ferry cleared the berth and started making way; however, as it approached the breakwater the inbound ferry was spotted and the risk of collision immediately identified. The outbound ferry's master urgently attempted to agree a suitable passing arrangement with the inbound ferry's master over very high frequency (VHF) radio, but the situation remained unclear.

The outbound ferry's master put the helm hard to starboard and applied full bow thruster power to starboard. The outbound ferry's bow swung clear, but the stern was swinging to port towards the inbound ferry so the master stopped the bow thruster and applied port rudder to avoid collision. The ferries passed one another at about 50m (Figure 2).

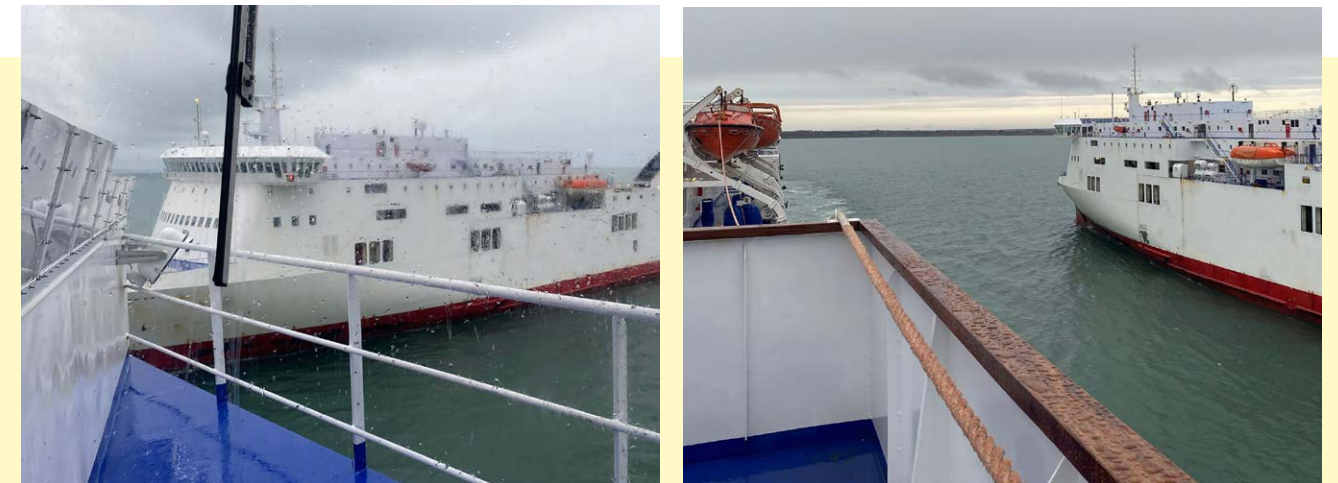
Figure 2: The close-quarters situation

2. **Equipment** → The use of VHF radio for collision avoidance can be unhelpful and may even prove dangerous. In this instance, the radio communication delayed the manoeuvre and led to confusion between the bridge teams. Although it is useful in limited circumstances, VHF is not a collision-avoidance tool and must only be considered a navigation aid when it is appropriate to do so.

4. **Action** → The inbound ferry did not communicate to harbour control that they needed to maintain headway for steerage and the strong breeze would have made waiting or loitering at the lateral buoy difficult. Maintaining a higher speed to reduce drift is sometimes necessary; however, actions contrary to harbour control's instructions should be communicated immediately to assess the impact on other traffic and maintain a shared mental model.

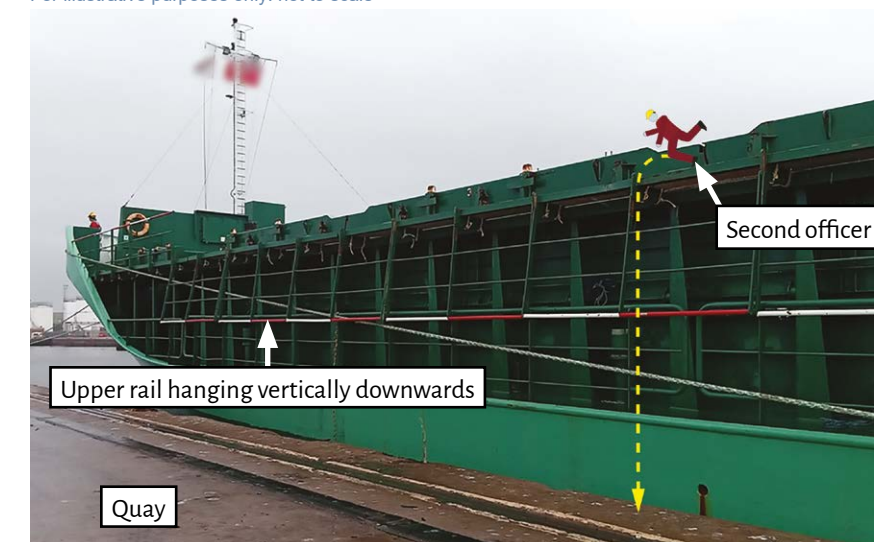
Figure 2: Illustration of the second officer falling to the concrete quay

The 2/O was leaning towards the unsecured rail when it suddenly started to fall outboard. The 2/O, who was not wearing a safety harness fixed to the catwalk, lost their balance (Figure 2) and fell about 3.5m to the concrete quay below. The 2/O was in hospital for more than 10 days, having broken both legs in an attempt to land on their feet.

1. **Procedure** → The shipboard risk assessment for this task required anyone working aloft or over the ship's side to wear a fall arrester. Following safety procedures increases the opportunity to identify hazards and determine what equipment or control measures are needed to mitigate them and keep people safe.
2. **Equipment** → A safety harness and appropriate restraint tether would have prevented the fall. Personal protective equipment (PPE) may be deemed uncomfortable to wear and will likely require adjusting to allow you to work effectively, but it is essential when carrying out high-risk tasks such as working at height.

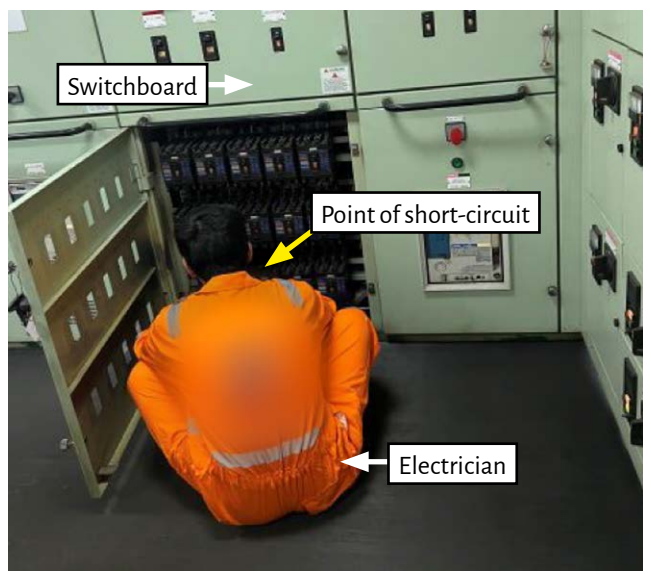
Figure 4: Position of the electrician

heat and blinding light. A burst of hot gas and molten metal exploded from the panel onto the electrician's face and chest (Figure 4).

The ship's engineers were alerted to a problem with the switchboard when the remote machinery alarm system sounded in the mess room. As the engineers headed to the engine room, the electrician arrived on the ship's bridge with serious burns to their face and chest. The following day, the electrician was transferred to hospital for medical treatment and later repatriated to recuperate at home. There was significant damage to the ship's main switchboard.

2. **Plan** → Working alone without a permit to work, LOTO procedure or agreed safe system of work increases the risk of an accident. The work was unexpected and therefore not included in the day's planning meeting. New work requires a new plan, regardless of time pressures. Maintenance or repairs to live equipment must undergo thorough risk assessment before starting work and, in all cases, should only be completed in exceptional circumstances and under the strictest control.

3. **Observe** → This accident was avoidable because there were opportunities to stop the work and reassess the risks. Everyone has a responsibility to be alert to what is happening around them and should feel empowered to intervene and stop any work that raises safety concerns.
4. **Equipment** → Working near live electrical equipment requires specific tools and PPE. The use of uninsulated tools while working in a live switchboard invited a short-circuit and the electrician, who was not wearing face protection, was lucky not to lose their eyesight in the accident.

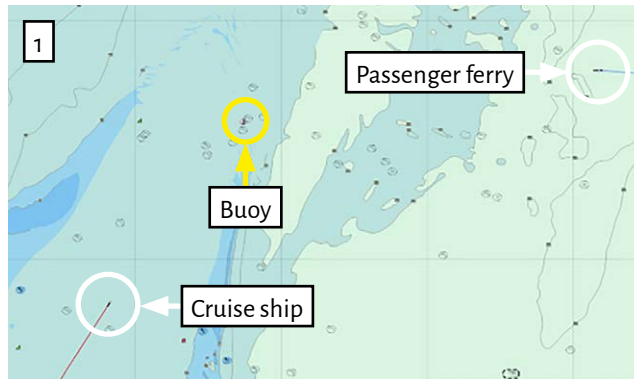
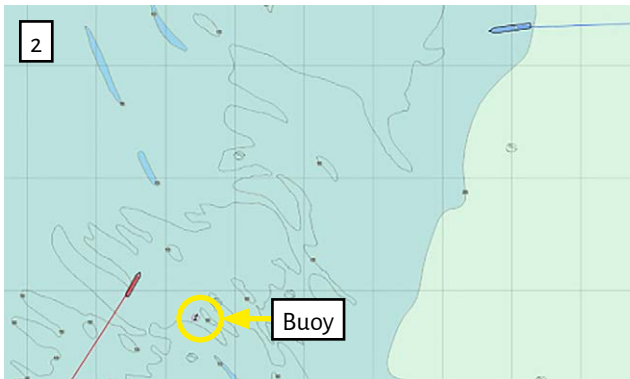
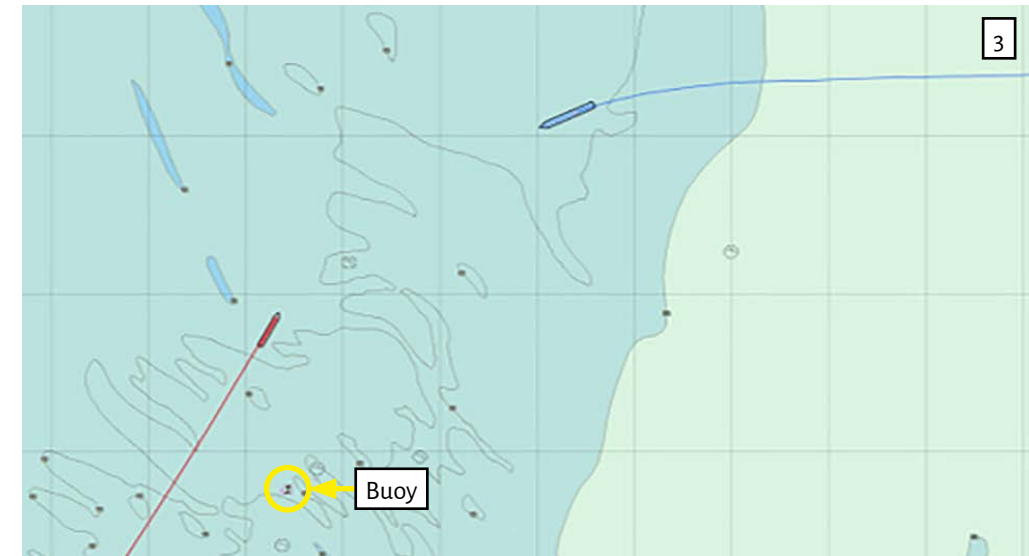
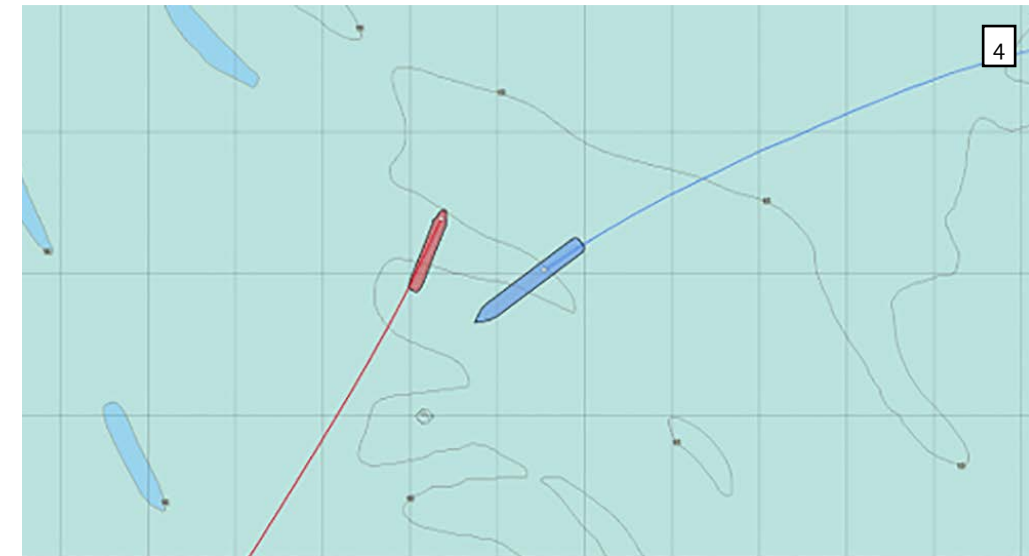
Figures: The near miss sequence

The cruise ship had disembarked its pilot and was heading north out of the harbour limits when vessel traffic services (VTS) contacted the officer of the watch (OOW) on VHF radio to make them aware of an inbound ro-ro ferry from the east. Both vessels were due to converge on the same north cardinal buoy at around the same time and the cruise ship's OOW announced their intentions to VTS to pass *port to port* with the ferry. This was heard by the ferry's OOW, who then made an alteration of course to the north to create more space for the cruise ship at the buoy.

Expecting the cruise ship to alter course to starboard as it passed the north cardinal buoy, the ferry's OOW altered their own course to port to approach the channel. Confused by this, the cruise ship's OOW attempted to call VTS several times on VHF radio to request them to ask the ferry to come further to port and pass the cruise ship's stern. However, the first three VHF radio calls did not transmit due to a faulty call button on the radio handset.

The cruise ship's OOW eventually transmitted the message to VTS as the two vessels moved ever closer to each other. VTS passed the cruise ship's message to the ferry, which altered further to port in response. The cruise ship's OOW also made an alteration of course to port and passed closely ahead of the ferry.

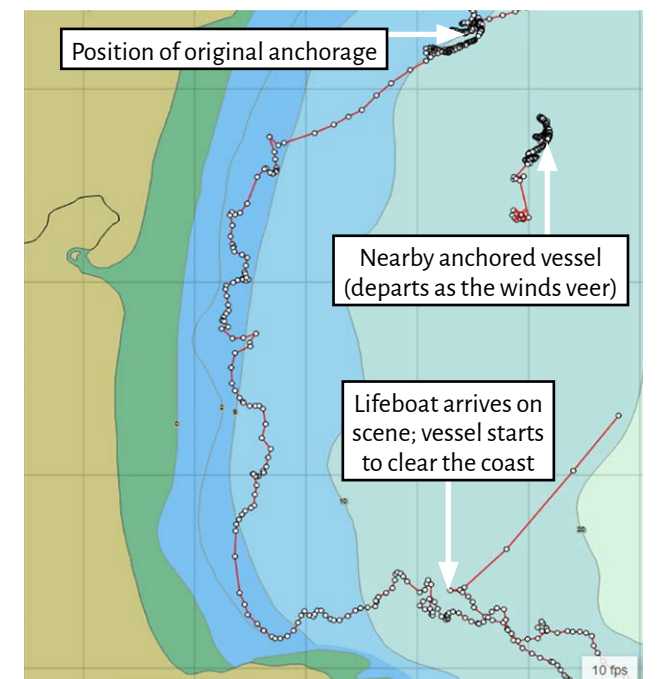
Figure: Plot showing the track of the cargo vessel as it dragged anchor along the shoreline

As the storm winds veered to the north-east the cargo vessel lost all shelter; it started to drag anchor and, 25 minutes later, was dangerously close to land on a lee shore. The master and crew fought hard for 2 hours to recover their anchor and proceed out to sea, during which the ship dragged southwards along the coast (see figure) and was within a few metres of grounding on several occasions.

managed to recover the anchor and make passage to their next port. After an exceptionally tiring and perilous few hours, it was extremely fortunate that the vessel emerged unscathed and avoided being wrecked on the coast.

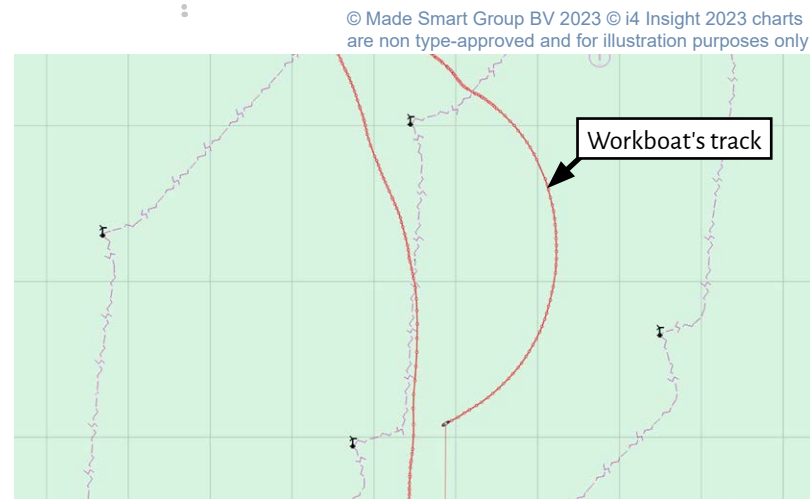
Figure 1: The navigational track of the workboat, showing its slow turn to starboard

turbines. Meanwhile, the mate was on the aft deck completing some familiarisation training and the crewman busied themselves organising the on board stores. The master was working at the aft-facing chart table on the bridge, but had become engrossed in paperwork and lost track of time. The workboat was travelling at 5kts and, without the autopilot switched on, started turning slowly to starboard (Figure 1).

The master was shocked to see one of the wind turbine towers looming ahead when they looked up and turned to face forward. The collision happened before there was chance to react.

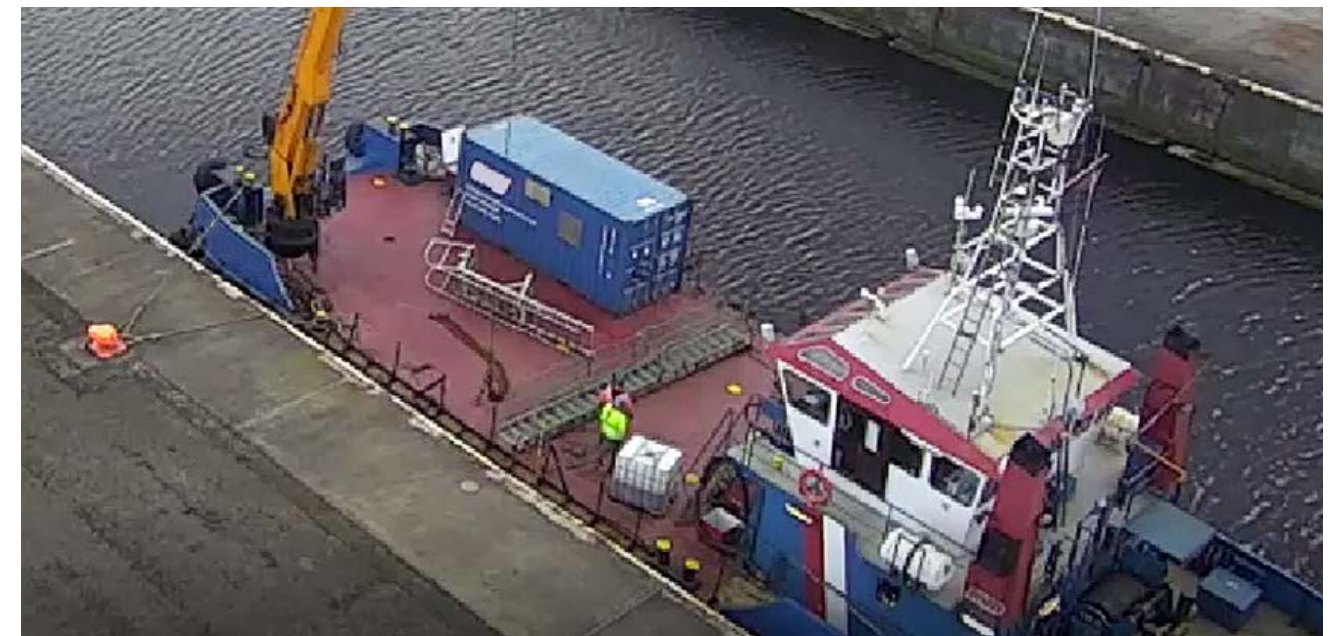
Figure 3: Locking out at the end of the day's work

the water level in the lock (Figure 3). Language difficulties hindered the communication but, after several attempts, the lock operator received a positive acknowledgement from the master that they understood these intentions. However, the workboat's mooring lines were not adjusted as the water levels in the lock started to reduce and the workboat momentarily listed to starboard as some of the mooring lines became rigid (Figure 4). A deckhand used a knife to cut one of the breast lines to release the tension, causing the line to whip out and the vessel to jolt back onto an even keel (Figure 5). Luckily no one was hurt, either on the lock or on board.

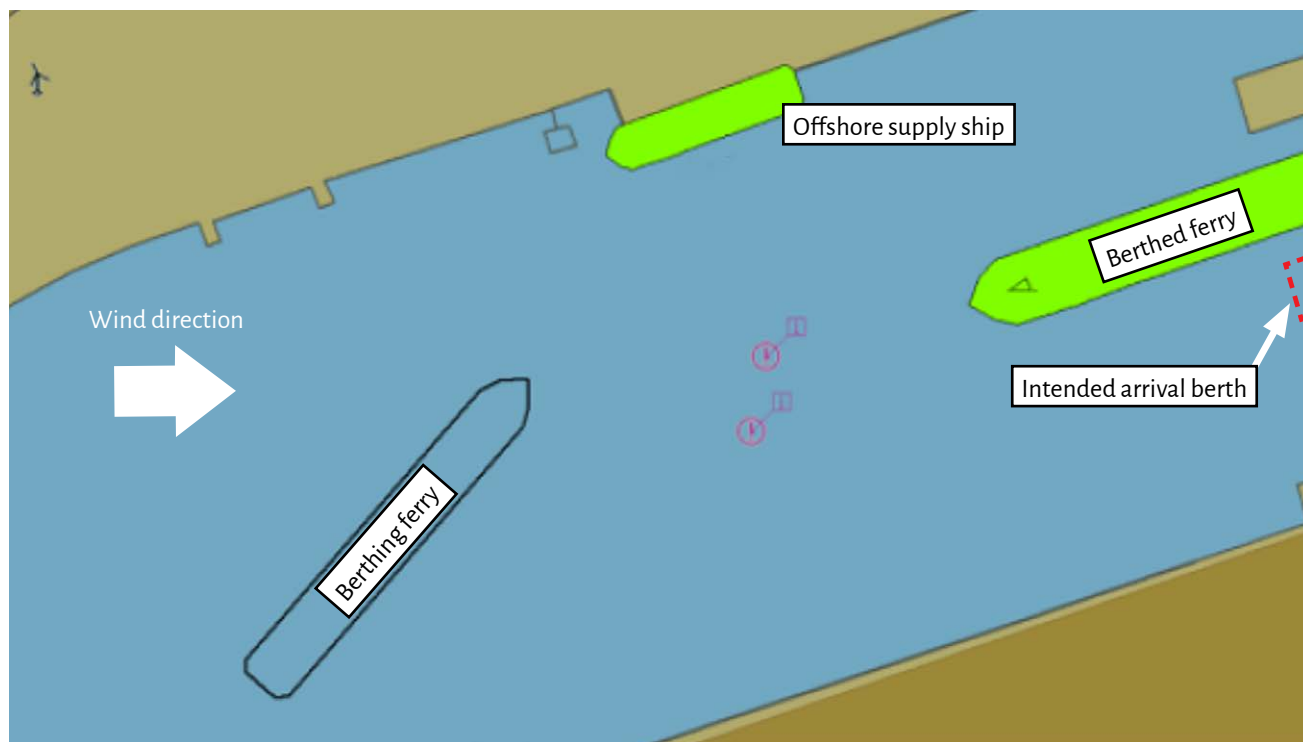
Figure 1: The ferry on approach to its intended linkspan

A ro-ro ferry was attempting to berth in a small northern European port at night in high winds. The three operational linkspans at the ferry port required vessels to moor stern to and another ferry occupied the middle linkspan (Figure 1). As the ferry entered the harbour the wind was

blowing from the west at about 35kts, which met the company's upper wind limit for permissible berthing. The ferry had to perform a 180° turn within the harbour to enable it to back onto its intended linkspan.

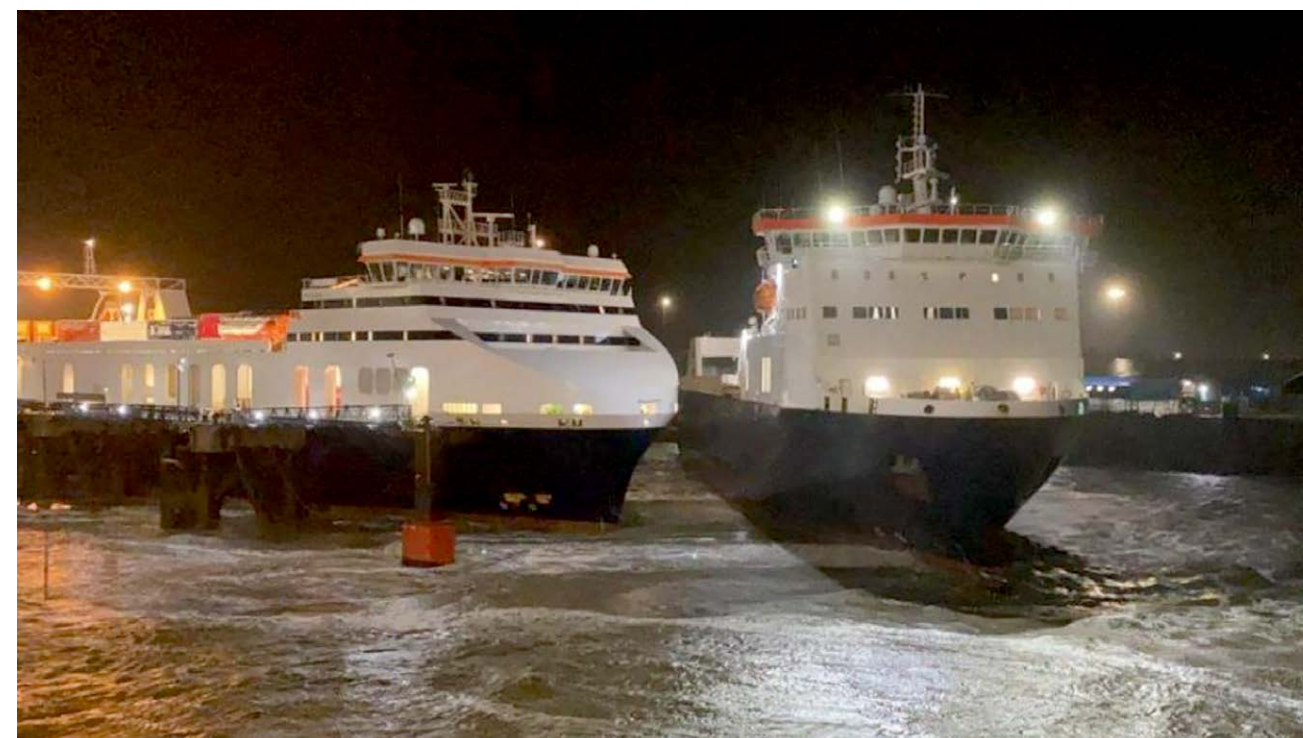
Figure 2: The two ferries just before the collision

The wind increased to around 60kts as the ferry began to turn, pushing it very close to an offshore supply ship berthed on the northern breakwater inside the harbour. The crew of the ferry used the bow thruster and main engines to hold the vessel up into the wind, but the force was too strong for the vessel to hold position while positioned fully beam on to it. The ferry was blown eastward

toward the ferry already berthed in the middle linkspan and the two vessels collided, the moving ferry hitting the bow of the stationary ferry with its starboard shoulder (Figure 2).

The damage to both vessels was assessed and the incoming ferry departed the harbour and anchored until the wind abated; it berthed later that evening without further incident.

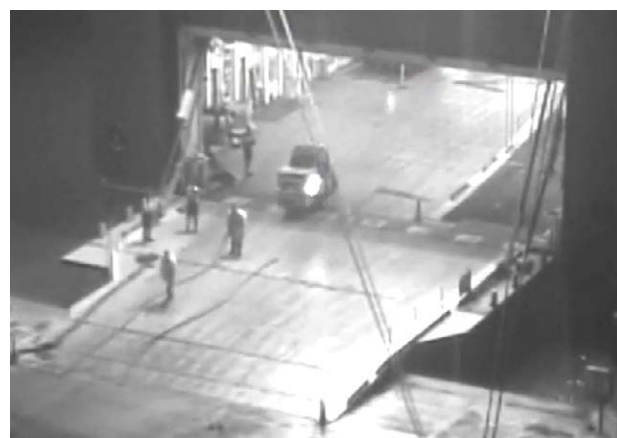
Figure: Forklift truck and stevedores on ramp

The ferry's staff were responsible for simultaneously supervising the offloading of cars and palletised cargo, which was undertaken using forklift trucks driven by stevedores. After the cars had been offloaded the crew prepared to back load excavators onto the ro-ro's deck, a process that required the positioning of lengths of heavy rope on the stern ramp. At the same time as two stevedores lifted the first length of rope and were moving it across the centre of the stern ramp, a forklift truck with a pallet of slate was being driven off the ferry (see figure).

The forklift truck driver did not see the stevedores on the stern ramp and the stevedore nearest to the approaching forklift truck was standing with their back to the ferry and did not see the oncoming forklift truck. The forklift truck driver was wearing ear defenders and did not hear a

shouted warning from the crew in time to prevent the forklift truck striking the stevedore on the leg, causing multiple fractures.

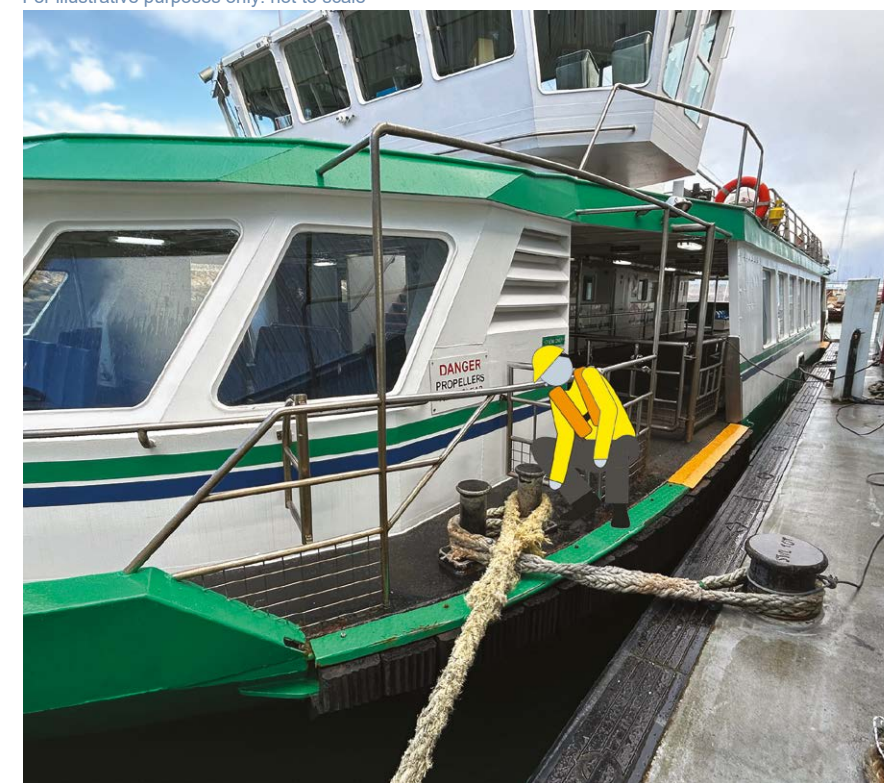
Figure: Trainee crew member releases the mooring rope

The ferry's crew quickly raised the alarm and the master regained control of the vessel, which allowed the crew member to release their hand. The casualty was taken to hospital for treatment and subsequently was signed off work for several weeks.

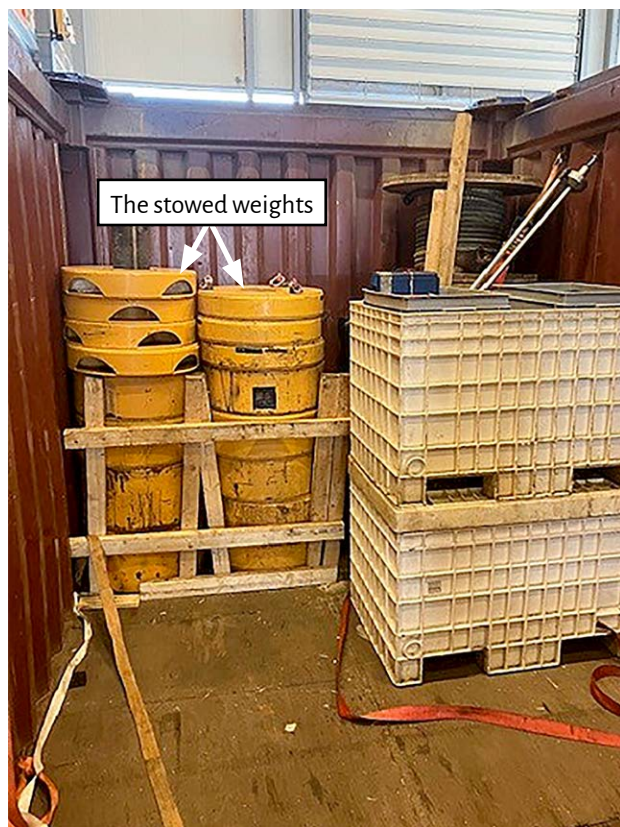
Figure 1: Weights loaded in container

Nearly 8 tonnes (t) of weights had been stacked in the back corner of the container when the equipment was originally loaded into the container (Figure 1).

When an unbalanced load is lifted, it will naturally swing to put its centre of gravity directly under the suspension point. Such a load will also alter the share of the weight that each part of the

lifting gear bears. In this case, the imbalance from the stowed weights caused the container, which weighed more than 16t in total, to swing towards the banksman. There was nothing the crew could do to stop its movement (Figure 2).

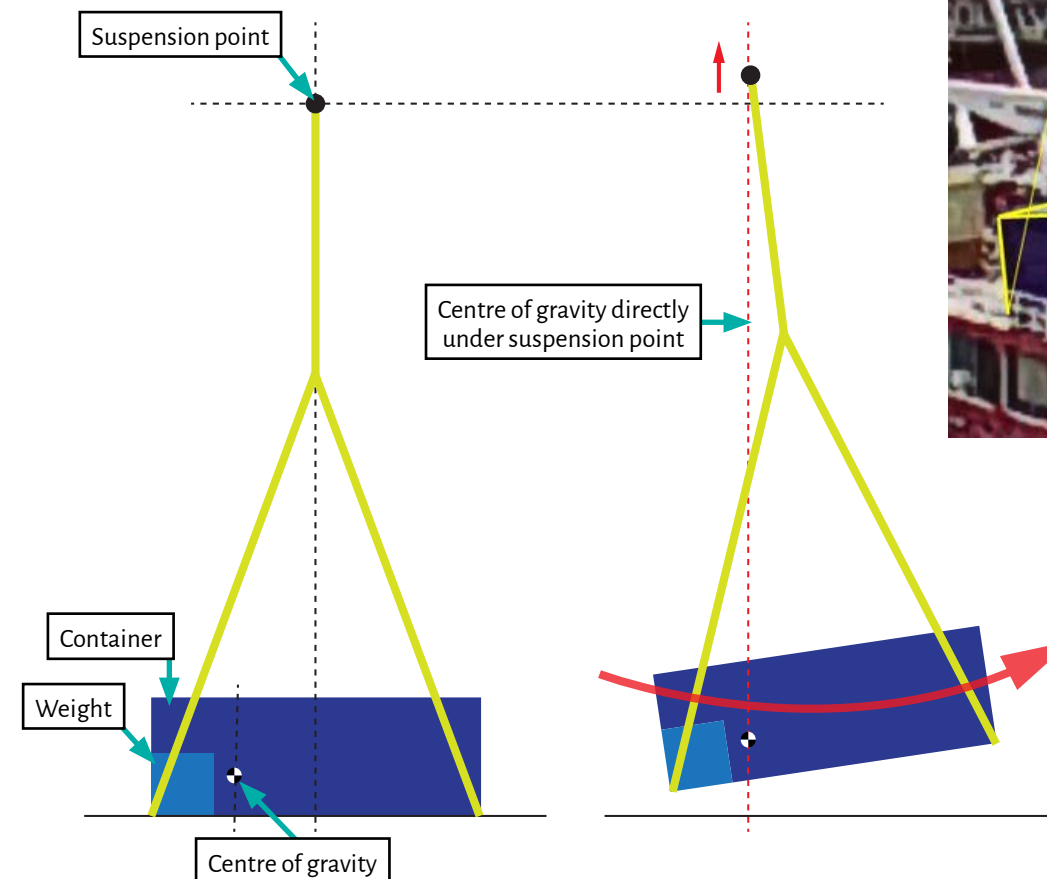
Figure 2: Effect of unbalanced load on lifting operation and (inset) CCTV still, showing container position following lift

1. **Plan** → The distribution of load is as important as the total weight when preparing a lift and its effect on the lifting operation should be carefully considered in the total lifting plan. In this case, neither the crew on board nor the crane driver were prepared for the swing that the unbalanced load caused when the container was lifted.

3. **Equipment** → There are occasions when an unbalanced load will need to be lifted. To facilitate this, you can either use slings of different lengths to lift the load directly above its centre of gravity or a spreader beam to evenly distribute the weight and make sure the load is lifted vertically.

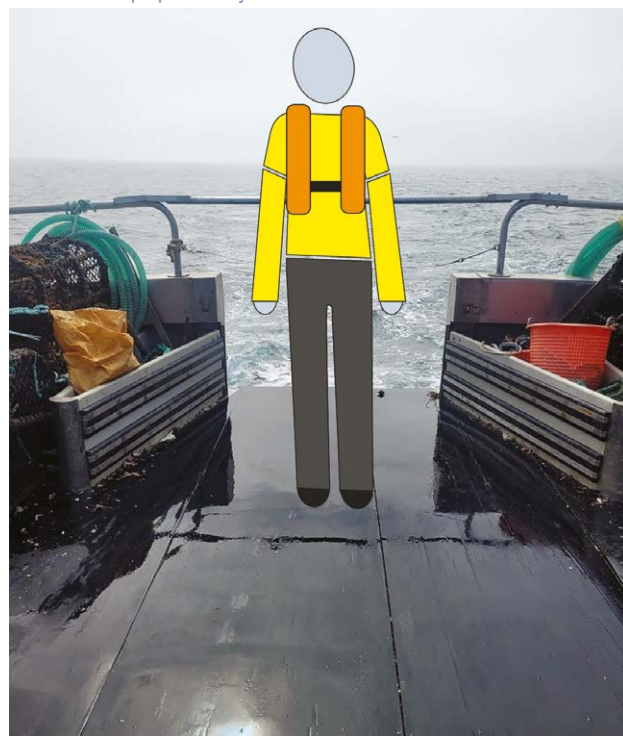
the second deckhand to recover their crewmate back on board through the shooting hatch opening. The casualty spent 2 minutes in the water and fortunately suffered no ill effects.

Figure: Deckhand's position at the shooting hatch

- Hazard** → Prevention is better than cure. Consider alternative preventative safety measures when working on open and wet decks near openings or railings, such as positioning on deck and the use of safety harnesses and lanyards where possible. MGN<sup>1</sup> 571 (F) *Fishing Vessels: Prevention of Man Overboard* provides guidance on the importance and benefits of conducting dynamic risk assessments to mitigate hazards.

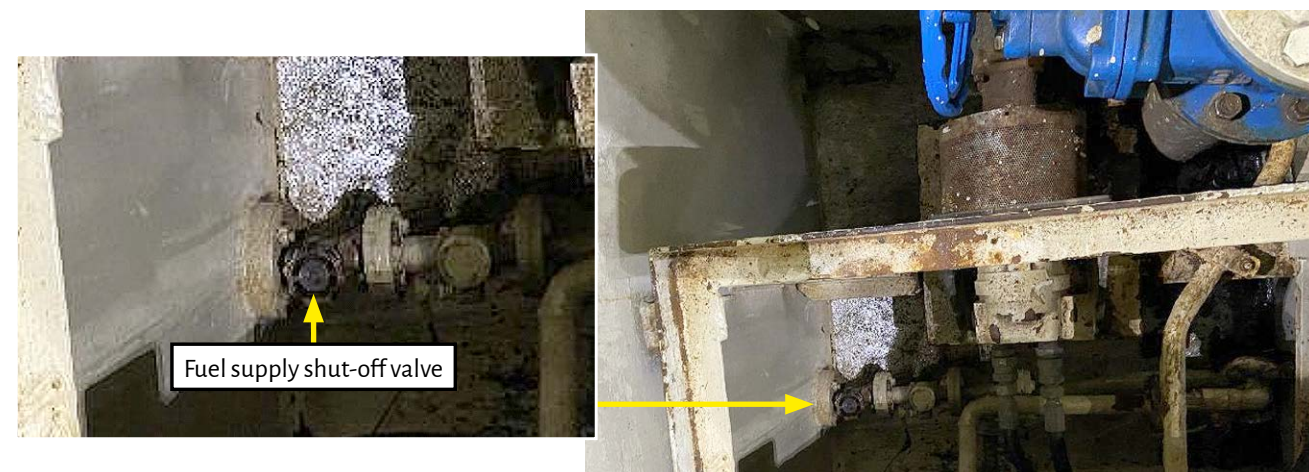
A fishing vessel was on a routine day trip when the peace was shattered by the sounding of the engine room smoke alarm. The crew went to investigate and found smoke emanating from a new alternator they had recently fitted to the engine. Despite their attempts to tackle it with portable extinguishers, the fire raged on and the crew were unable to reach the fuel supply shut-off valve (see figure) to stop the engine.

Figure: Fuel supply shut-off valve

- Equipment** → In an attempt to save money the owner had fitted a poor-quality alternator, which was replaced with a genuine spare part following the accident. Never be tempted to cut corners when repairing a vessel; the consequences can be expensive and could prove to be fatal.

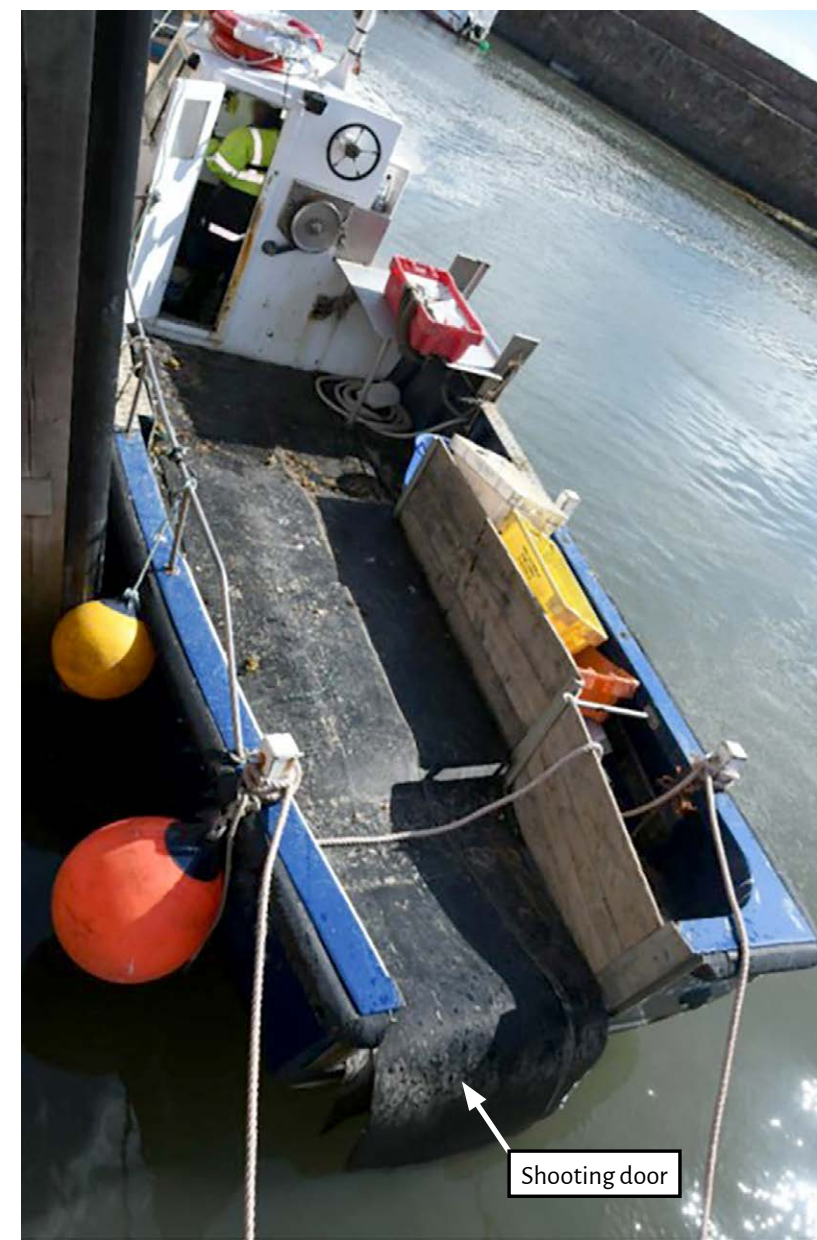
shooting door (Figure 2). The skipper's personal flotation device (PFD) automatically inflated on contact with the water, keeping them afloat and their face clear of the water. However, the skipper did not have an easy means by which to reboard their vessel and no method to raise the alarm while in the water and they succumbed to cold water immersion.

Figure 2: The shooting door (drop-in closing board removed)

- Procedure** → Fishers are advised to follow industry guidelines to minimise the likelihood of being pulled or falling overboard; a barrier between the fisher and the fishing gear during every phase of the fishing process and the wearing of a tethered safety harness offers the best protection against unexpected events.

- Equipment** → Fishers should always wear a PFD to help keep them afloat should they fall overboard. As this case demonstrates, cold water immersion can be fatal and it is vital to reboard as soon as possible. Wearing a personal locator beacon (PLB) that can be operated while in the water also improves the chances of rescue and survival.

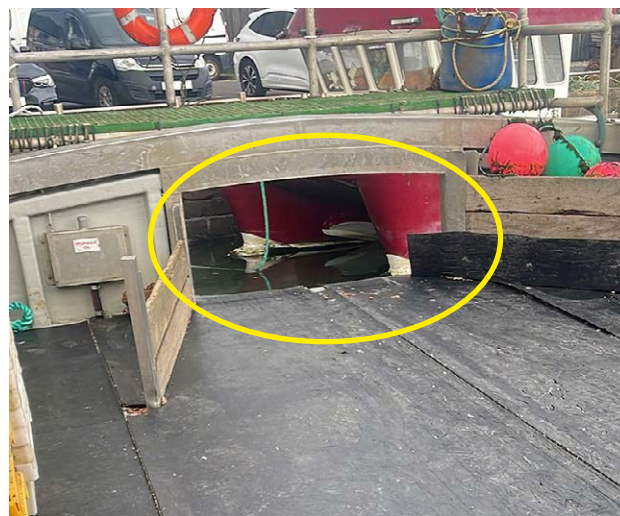
On a clear spring morning in smooth seas and with light winds, the three crew of a potting vessel were starting to shoot the gear after rebaiting the pots. The usual practice on board was for the crew to stand at the side of the working deck as the back rope and pots payed out through the coverless shooting hatch in the stern (Figure 1). However, on this occasion, one crew member was standing in the fish bay area (Figure 2) where the float line was coiled (Figure 3). As the line payed out, the crew member's leg became entangled in a bight of float line and they were pulled overboard after the last pot.

Figure 1: The coverless shooting hatch

1. **Procedure** → The usual working procedure on board the vessel was for the crew to stand aside when the vessel was shooting pots, to avoid becoming entangled in any lines or being struck by moving equipment. In this case, the crew member deviated from the usual procedure and was standing in an area where coiled lines were attached to the fleet of pots that were being shot.
2. **Observe** → The crew member did not observe their surroundings and therefore failed to identify the risk of standing near the coiled lines. Conversely, the skipper was observing the shooting operation closely from their position inside the wheelhouse, which meant that the skipper and other crew member were able to react quickly when they saw their crewmate being dragged overboard.

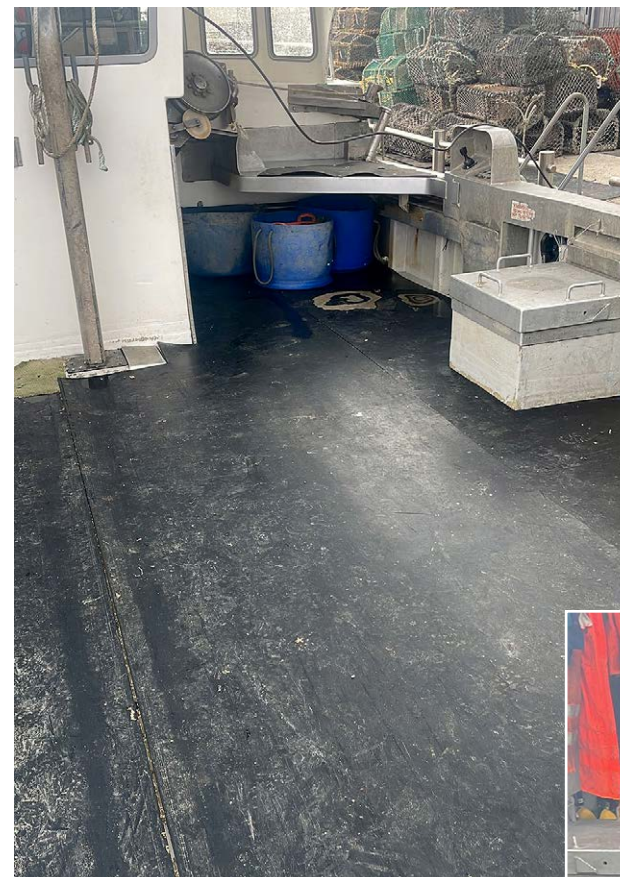
Figure 2: The fish bay area where the crew member was standing

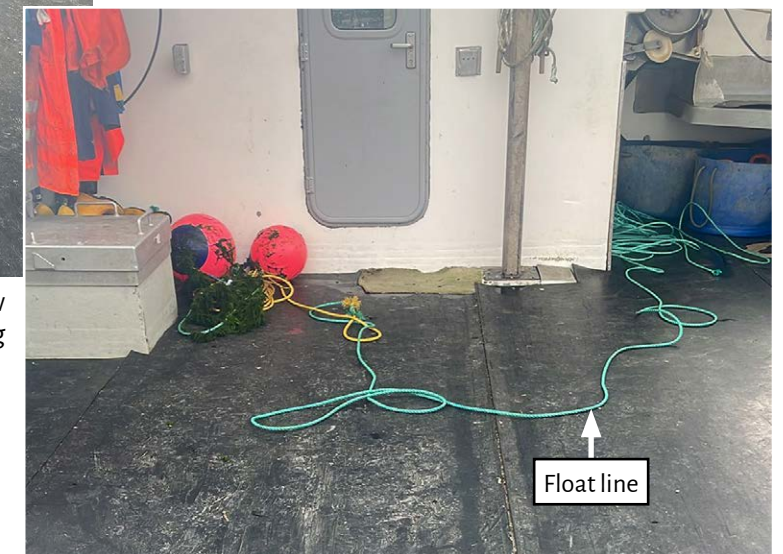
Figure 3: The float line coiled on the working deck

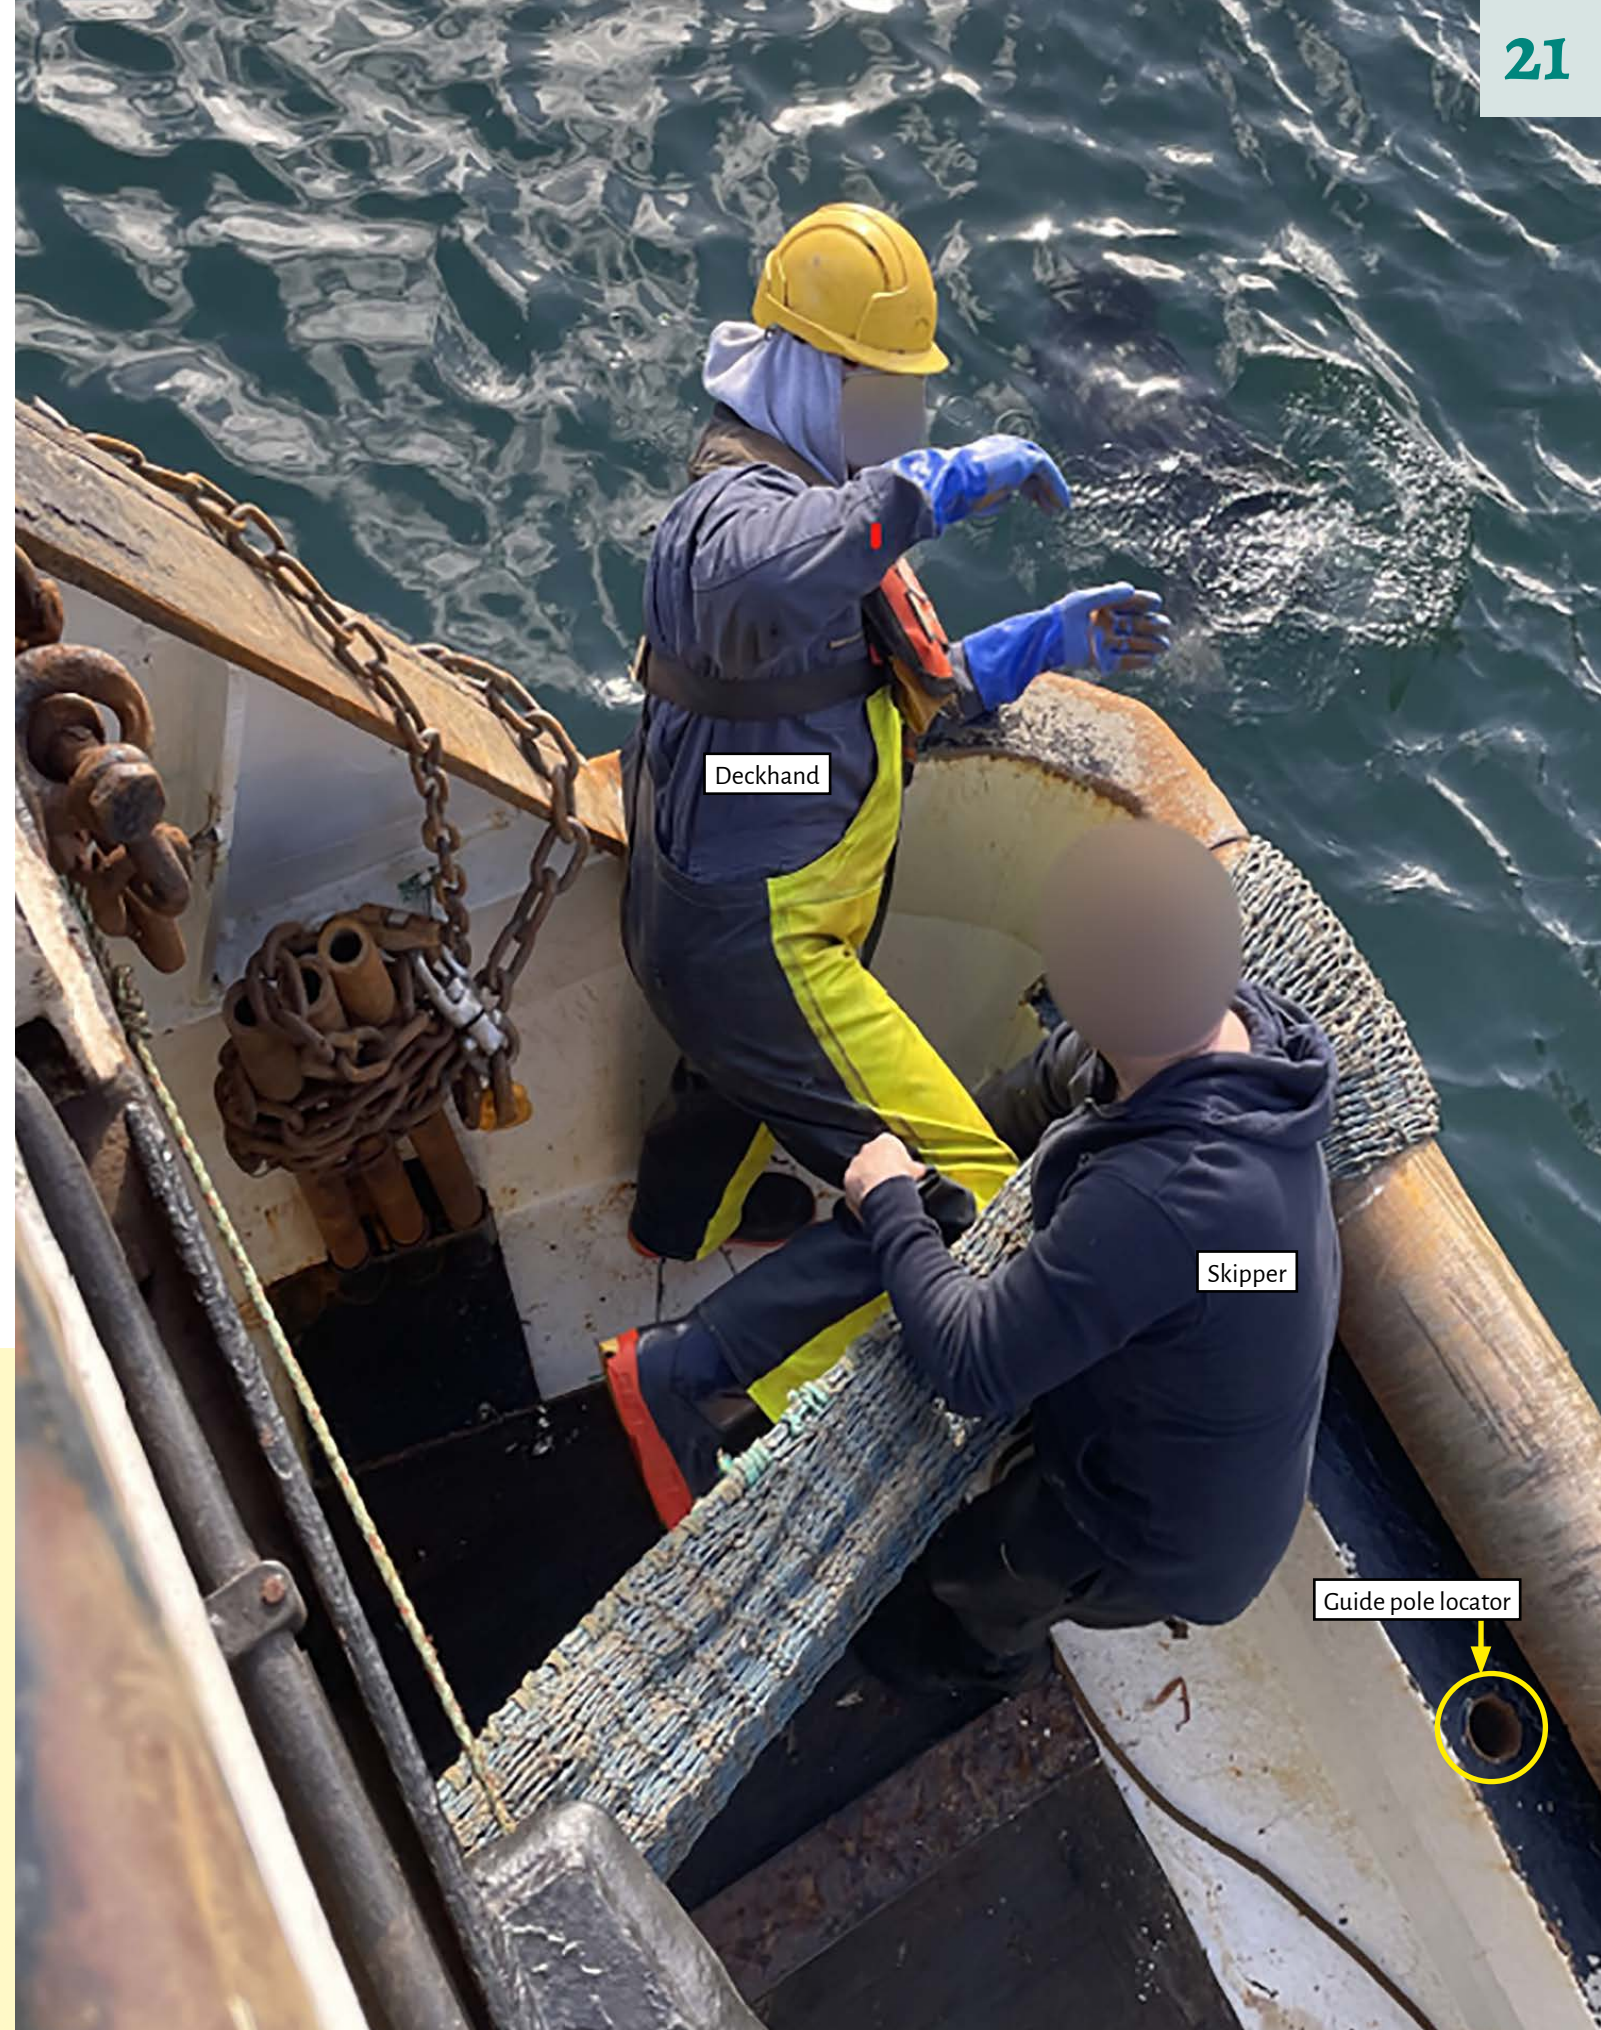
Figure: Reconstruction, showing the deckhand standing in working position between the bulwark and net

- Hazard** → An unconstrained net during hauling is a significant hazard in anything other than the most benign conditions. The operation requires careful monitoring to prevent shortcuts being taken or complacency creeping in. Reminding crew of the hazards before they start working the net is advised.

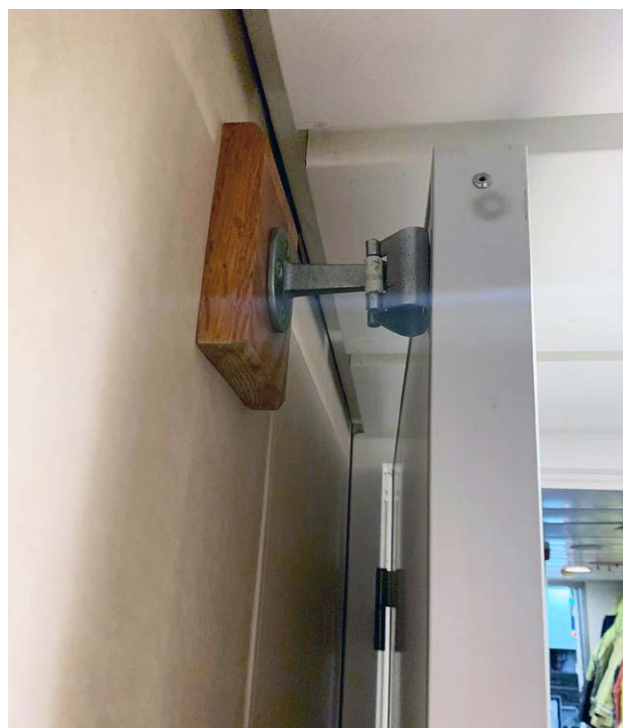
Figure 1: The hold-open mechanism on the door

- Check** → Regular inspections of door mechanisms helps prevent accidents caused by doors unexpectedly opening or closing while the vessel is moving. Make sure doors are securely retained in their open and closed positions and that the mechanisms for doing so function correctly. The fitting of pneumatic door closers can reduce the force with which doors operate.
