# SAFETY DIGEST

Lessons from Marine Accident Reports

2/2023

# MARINE ACCIDENT INVESTIGATION BRANCH

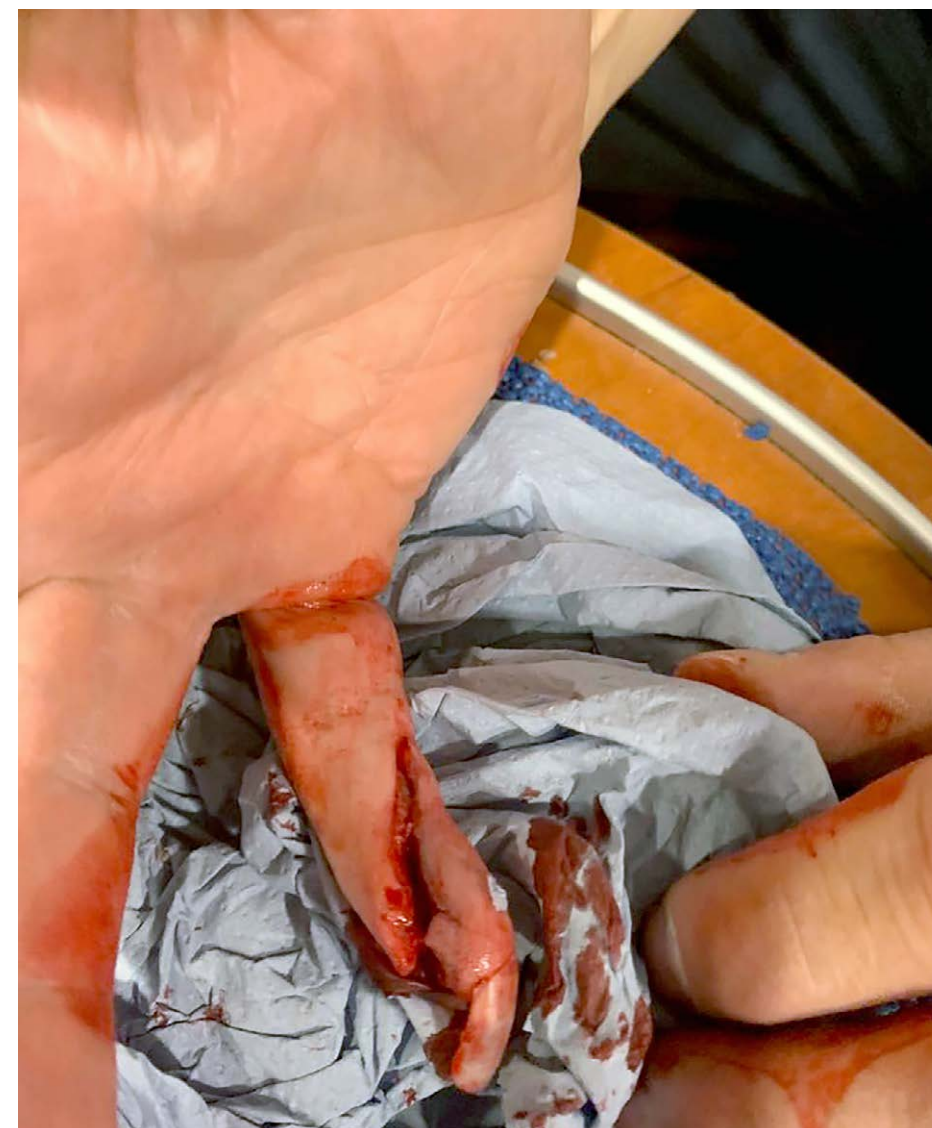
environmentally challenging conditions for about 10 hours, the injured crew member was airlifted from the fishing trawler and transferred to hospital where they underwent surgery. Fortunately, the surgeon managed to save the little finger.

Figure 2: The partially severed little finger

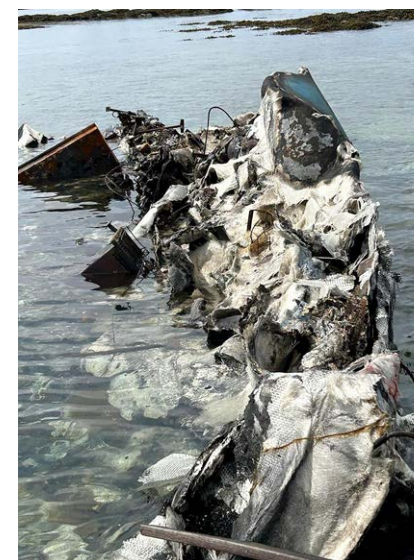
Figure: The remains of the vessel

The skipper used the VHF radio to transmit a “Mayday” call and was picked up by another sailing vessel and taken ashore. Fortunately, they had not sustained serious injuries and were treated for smoke inhalation and emotional shock; however, the sailing vessel burned down to the bilges and sank, eventually coming to rest on a sandbank (see figure).

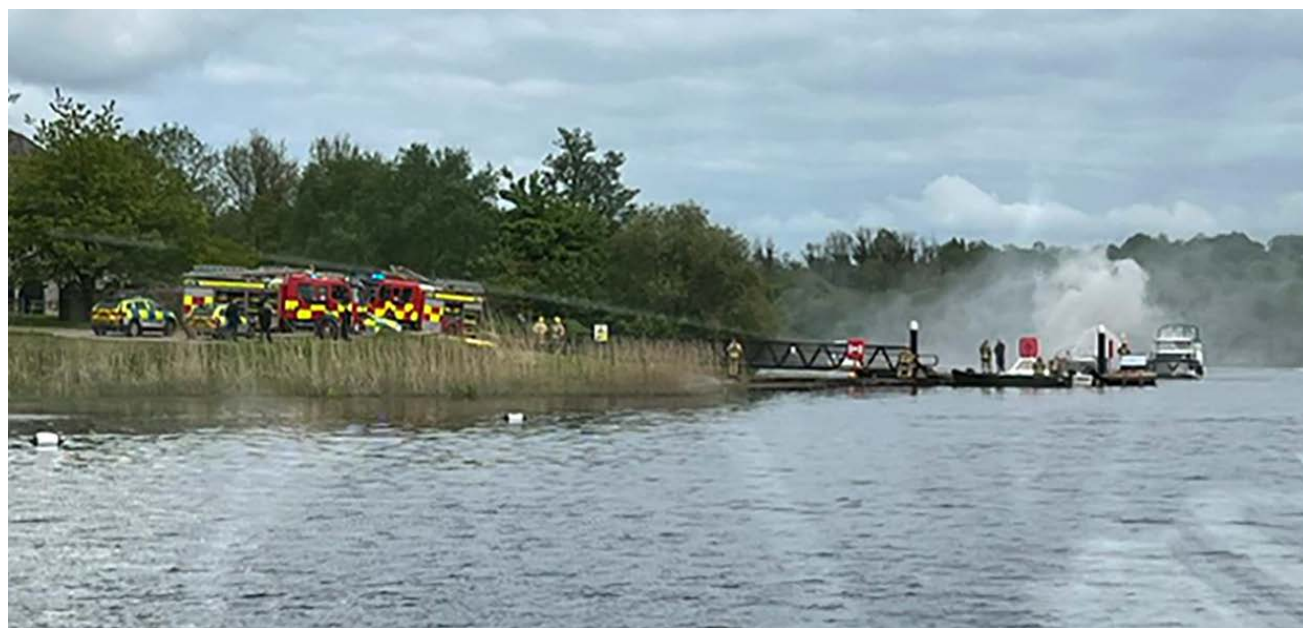
The emergency services arrived on the scene, having been called by marina staff. The fire brigade doused the yacht with water to extinguish the flames (Figure 1). The owner was recovered from the loch by police and medics

Figure 1: Emergency services attending the scene

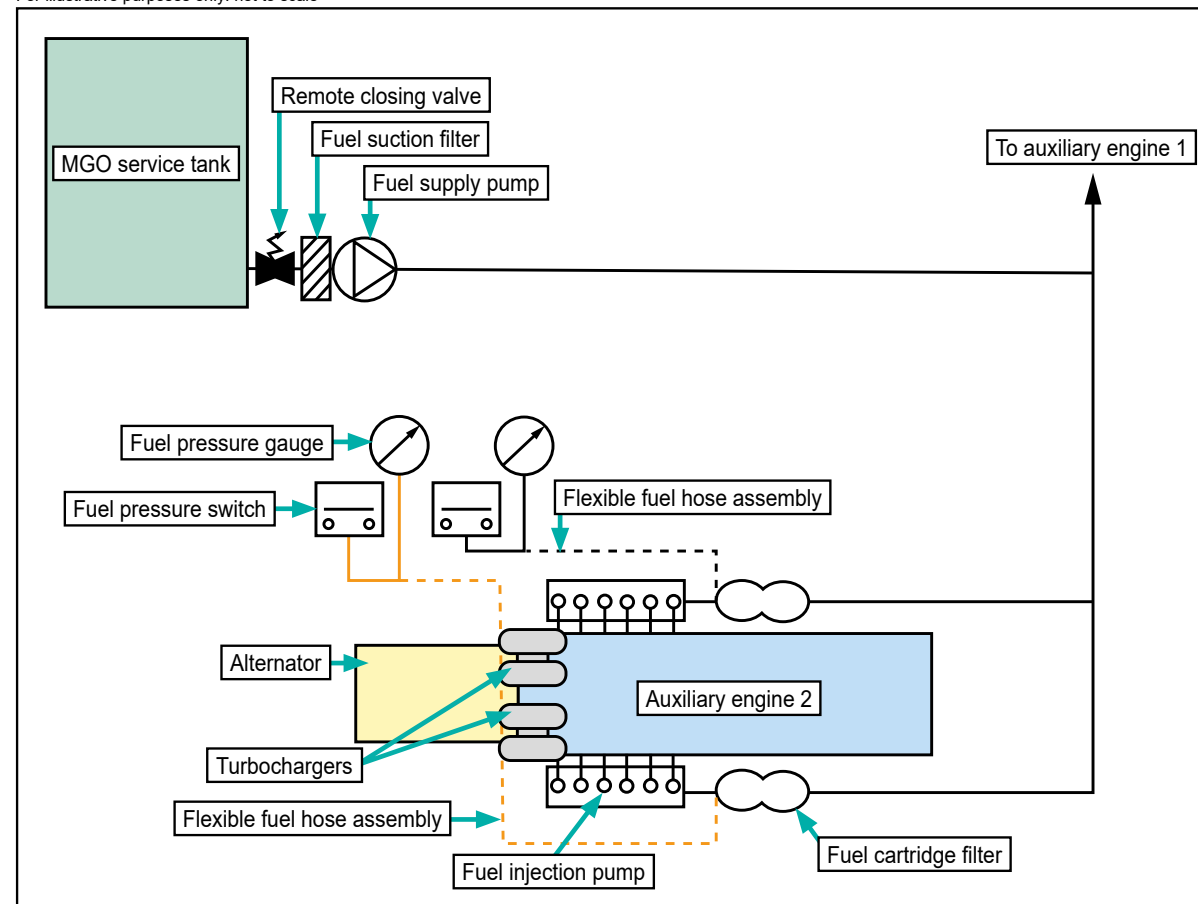
**Figure 2:** Schematic diagram of auxiliary engine fuel supply system

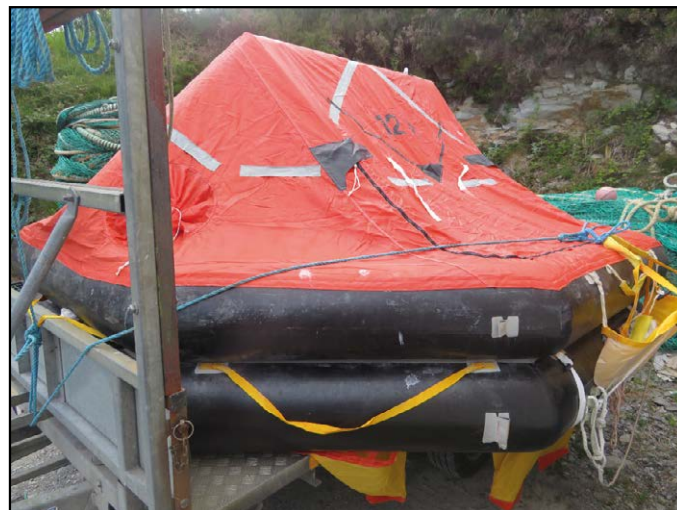
**Potential failure of**  
**Deutsche Schlauchboot GmbH (DSB) liferafts**  
**serviced by Comfer Marin SL, Marin, Spain**  
**identified following the foundering of the fishing vessel**  
***Piedras* (FD 528)**  
**south-west of Mizen Head, the Republic of Ireland**  
**on 1 June 2022**

Recovered *Piedras* starboard liferaft
